# Access Compliance Report Public Rights-of-Way (Curb Ramps)

Main Street: S\_ESPLANADE\_ST Cross Street: E\_CENTER\_ST Location: NE

ADA ID: RPAT210927115847 Ramp Type: Type 4 - Parallel Initial Pass/Fail: Fail Overall Compliance: No Severity Score: 19

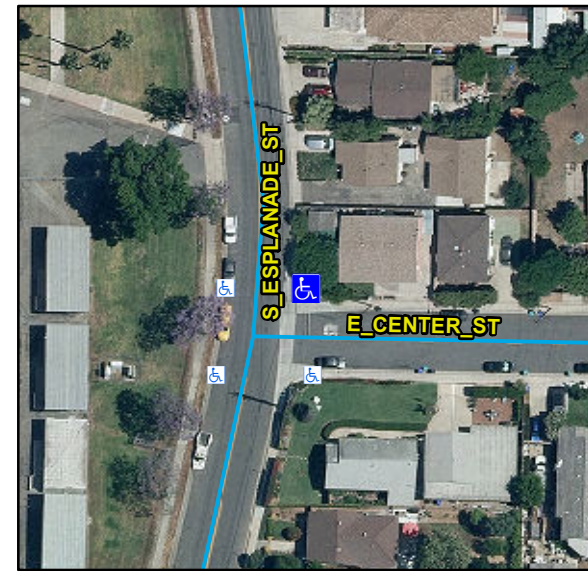
| Compliance | Description | Data | Compliance | Description | Data |
|---|---|---|---|---|---|
| No | Ramp Width LT (in) | 47 | No | Ramp Width RT (in) | 47 |
| Yes | Ramp Run Slope LT (%) | 5.3 | No | Ramp Run Slope RT (%) | 9.4 |

**Remove & Replace Curb Ramp With Two New Directional Ramps or Equivalent. Replace Spandrel.**
