# Access Compliance Report Public Rights-of-Way (Curb Ramps)

| Main Street: E_PEARL_ST | | Cross Street: EARLHAM_ST | | Location: | NW |
| ADA ID: RPAT210927132009 | Ramp Type: Type 4 - Parallel | Initial Pass/Fail: Fail | Overall Compliance: No | Severity Score: | 19 |

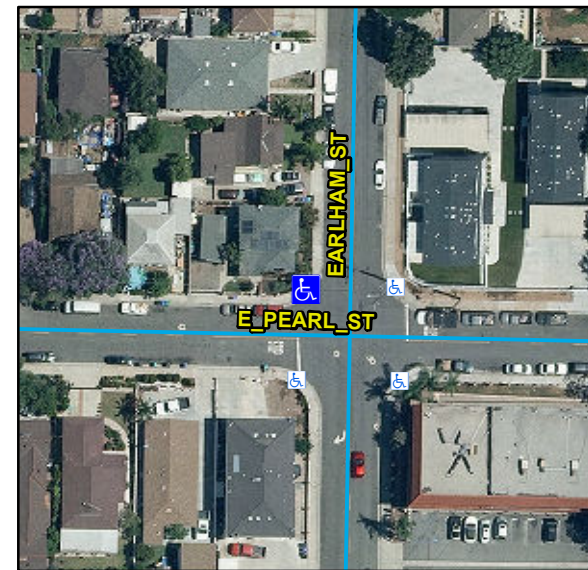
| Compliance | Description | Data | Compliance | Description | Data |
|---|---|---|---|---|---|
| No | Ramp Width LT (in) | 47 | No | Ramp Width RT (in) | 47 |
| Yes | Ramp Run Slope LT (%) | 4.9 | No | Ramp Run Slope RT (%) | 9.3 |

**Remove & Replace Curb Ramp With Two New Directional Ramps or Equivalent.**

**R304.5.1, R304.3.2, STD 1115**
