# Access Compliance Report Public Rights-of-Way (Curb Ramps)

Main Street: EARLHAM\_ST Cross Street: E\_PEARL\_ST Location: NE

ADA ID: RPAT210927132302 Ramp Type: Type 4 - Parallel Initial Pass/Fail: Fail Overall Compliance: No Severity Score: 2

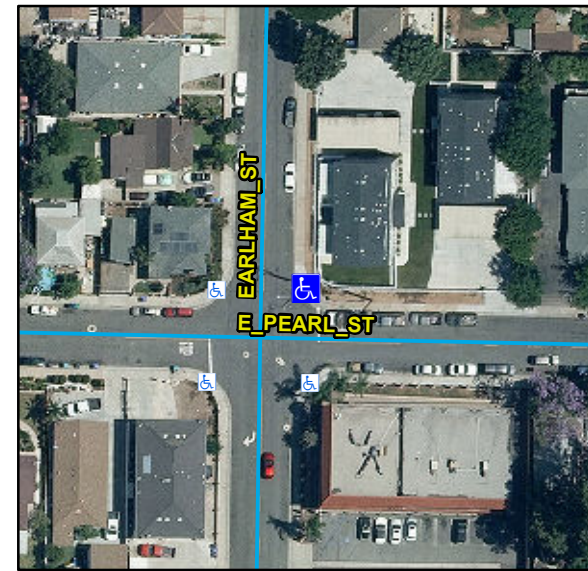
| Compliance | Description | Data | Compliance | Description | Data |
|---|---|---|---|---|---|
| No | Obstructions Present? | Yes | N/A | Utilities Present? | No |
| | Obstruction Types | Power Pole | | Utility Types | |

| Compliance | Description | Data | Compliance | Description | Data |
|---|---|---|---|---|---|
| No | Ramp Cross Slope LT (%) | 2.5 | No | Ramp Cross Slope RT (%) | 3.6 |

**Remove & Replace Curb Ramp With Two New Directional Ramps or Equivalent.**

**R304.5.3, R302.3, R402.2, STD 1115**
