# Access Compliance Report Public Rights-of-Way (Curb Ramps)

Main Street: E\_PEARL\_ST Cross Street: EARLHAM\_ST Location: SE

ADA ID: RPAT210927132544 Ramp Type: Type 4 - Parallel Initial Pass/Fail: Fail Overall Compliance: No Severity Score: 19

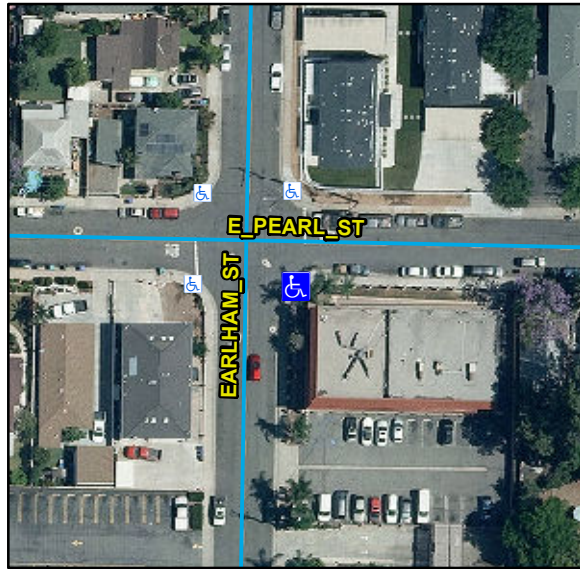
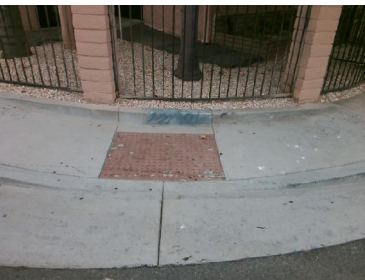
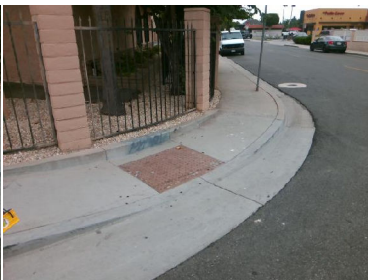
| Compliance | Description | Data | Compliance | Description | Data |
|---|---|---|---|---|---|
| No | Ramp Width LT (in) | 47 | Yes | Ramp Width RT (in) | 48 |
| No | Ramp Run Slope LT (%) | 10 | Yes | Ramp Run Slope RT (%) | 4.5 |

**Remove & Replace Curb Ramp With Two New Directional Ramps or Equivalent.**

**R304.5.1, R304.3.2, STD 1115**
