# Access Compliance Report Public Rights-of-Way (Curb Ramps)

Main Street: EARLHAM\_ST Cross Street: E\_PEARL\_ST Location: SW

ADA ID: RPAT210927132911 Ramp Type: Type 4 - Parallel Initial Pass/Fail: Fail Overall Compliance: No Severity Score: 19

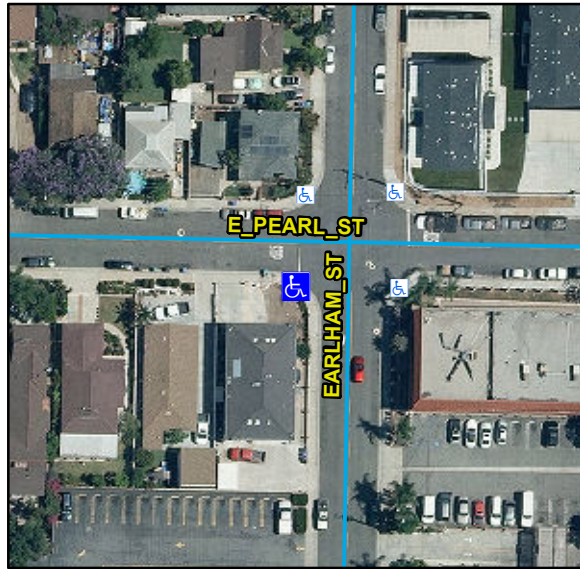
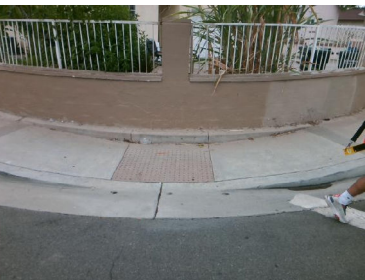
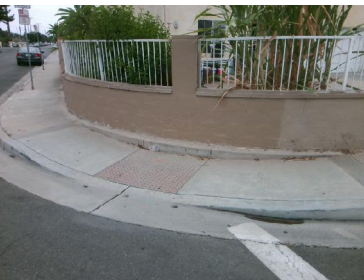
| Compliance | Description | Data | Compliance | Description | Data |
|---|---|---|---|---|---|
| No | Ramp Width LT (in) | 47 | No | Ramp Width RT (in) | 46 |
| Yes | Ramp Run Slope LT (%) | 6.3 | No | Ramp Run Slope RT (%) | 9.4 |

**Remove & Replace Curb Ramp With Two New Directional Ramps or Equivalent.**

**R304.5.1, R304.3.2, STD 1115**
