Access Compliance Report Public Rights-of-Way (Curb Ramps)

Main Street: S_ESPLANADE_ST **Cross Street:** E_PEARL_ST **Location:** NE

ADA ID: RPAT210927133725 **Ramp Type:** Type 4 - Parallel **Initial Pass/Fail:** Fail **Overall Compliance:** No **Severity Score:** 34

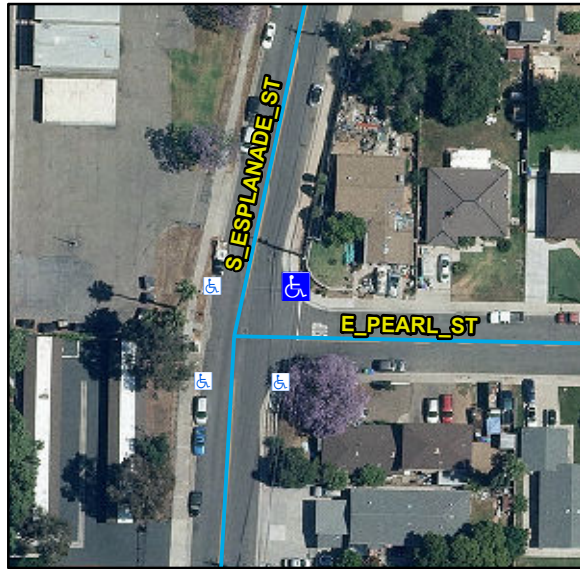
Compliance	Description	Data	Compliance	Description	Data
N/A	Ramp Length LT (in)	72	N/A	Ramp Length RT (in)	115
No	Ramp Width LT (in)	47	Yes	Ramp Width RT (in)	48
Yes	Ramp Run Slope LT (%)	5	No	Ramp Run Slope RT (%)	12.9
Yes	Ramp Cross Slope LT (%)	0.6	Yes	Ramp Cross Slope RT (%)	0.8
N/A	Landing Present	N/A	N/A	DWS Provided	N/A
N/A	Landing Length (in)	N/A	N/A	DWS Contrast	N/A
N/A	Landing Width (in)	N/A	N/A	DWS Length (in)	N/A
N/A	Landing Run Slope (%)	N/A	N/A	DWS Full Width	N/A
N/A	Landing Cross Slope (%)	N/A		DWS Offset Type	N/A
N/A	Landing Movement Obstructed?	N/A	N/A	DWS Offset Left (in)	N/A
	Landing Movement Type	N/A	N/A	DWS Offset Right (in)	N/A
N/A	Landing Shared	N/A			
N/A	Clear Space	Yes			
N/A	Clear Space To Crosswalk (in)	N/A			
N/A	Marked Crosswalk 1	No	N/A	Marked Crosswalk 2	No
	Crossing 1 Direction	W		Crossing 2 Direction	S
N/A	Marked Crosswalk 1 Width (in)	N/A		Marked Crosswalk 2 Width (in)	N/A

N/A	Ramp Inside Crosswalk 1	N/A	N/A	Ramp Inside Crosswalk 2	N/A
	Crossing 1 Slope (%)	2.3		Crossing 2 Slope (%)	2.7
	Crossing 1 Cross Slope (%)	0.6		Crossing 2 Cross Slope (%)	6.8
N/A	Gutter Ponding	N/A	N/A	Curb Slope	4.5
Yes	Gutter Lip Height (in)	0		Road Run Slope (%)	4.2
N/A	Gutter Run Slope (%)	N/A		Road Cross Slope (%)	0.8
N/A	Gutter Cross Slope (%)	N/A	Yes	Perpendicular Joint Present	Yes
Yes	Overall Surface Condition	Acceptable			
	Cross Gutter Present?	No		Spandrel Present?	No
	Replace Cross Gutter?	N/A		Replace Spandrel?	N/A

Possible Solutions:
Remove & Replace Curb Ramp With Two New Directional Ramps or Equivalent.

OC Std/PROW:
 R304.5.1, R304.3.2, STD 1115

Total Cost: \$ 4000
