# Access Compliance Report Public Rights-of-Way (Curb Ramps)

Main Street: E\_PEARL\_ST Cross Street: S\_ESPLANADE\_ST Location: SE

ADA ID: RPAT210927134045 Ramp Type: Type 4 - Parallel Initial Pass/Fail: Fail Overall Compliance: No Severity Score: 19

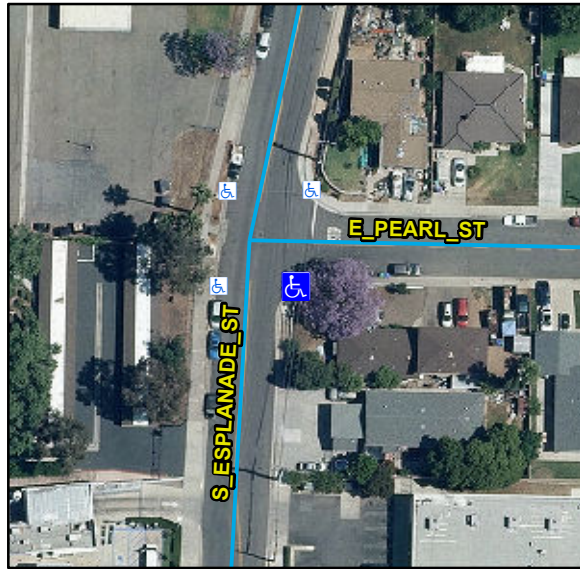
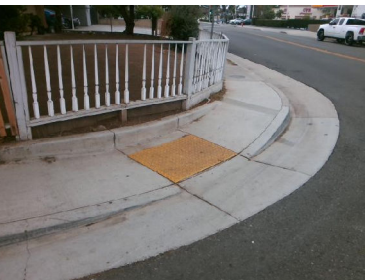
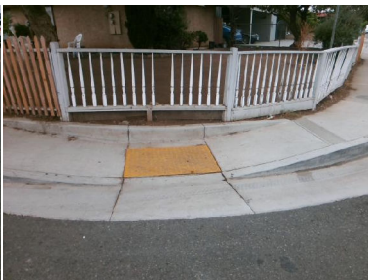
| Compliance | Description | Data | Compliance | Description | Data |
|---|---|---|---|---|---|
| Yes | Ramp Width LT (in) | 48 | No | Ramp Width RT (in) | 47 |
| No | Ramp Run Slope LT (%) | 11.1 | Yes | Ramp Run Slope RT (%) | 3.4 |

**Remove & Replace Curb Ramp With Two New Directional Ramps or Equivalent.**

**R304.5.1, R304.3.2, STD 1115**
