# Access Compliance Report Public Rights-of-Way (Curb Ramps)

Main Street: S\_ESPLANADE\_ST Cross Street: E\_CHAPMAN\_AVE Location: NE

ADA ID: RPAT210927134912 Ramp Type: Type 1 - Perpendicular Diagonal Initial Pass/Fail: Fail Overall Compliance: No Severity Score: 5

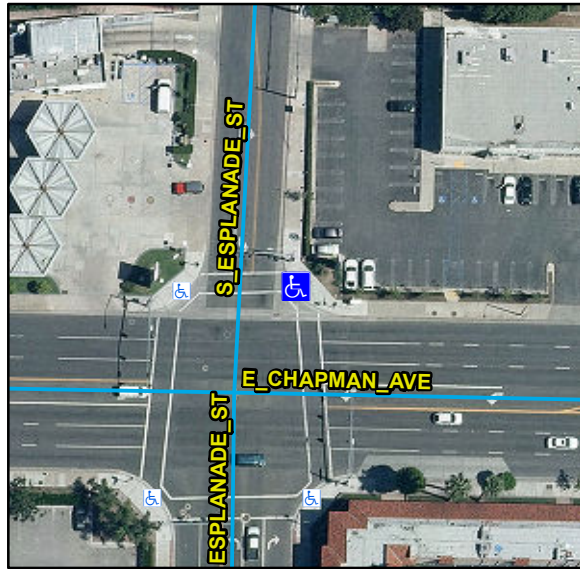
| Compliance | Description | Data | Compliance | Description | Data |
|---|---|---|---|---|---|
| No | Ramp Width (in) | 47 | | | N/A |

Remove & Replace Curb Ramp With Two New Directional Ramps or Equivalent.

R304.2.2, R304.5.1, STD 1115
