# Access Compliance Report Public Rights-of-Way (Curb Ramps)

Main Street: E\_CHAPMAN\_AVE Cross Street: S\_ESPLANADE\_ST Location: NW

ADA ID: RPAT210927135638 Ramp Type: Type 3 - Combination 1 Initial Pass/Fail: Fail Overall Compliance: No Severity Score: 15

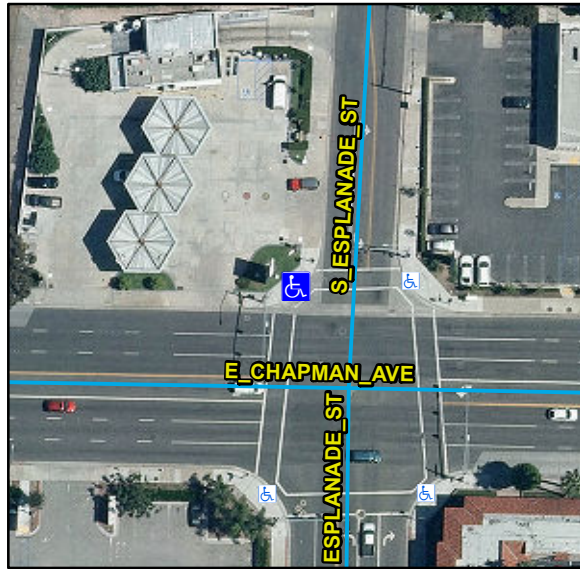
| Compliance | Description | Data | Compliance | Description | Data |
|---|---|---|---|---|---|
| No | Ramp Run Slope (%) | 8.5 | N/A | Flare Slope LT (%) | N/A |

Remove & Replace Curb Ramp With Two New Directional Ramps or Equivalent.

R304.2.2, STD 1115
