# Access Compliance Report Public Rights-of-Way (Curb Ramps)

Main Street: E\_PEARL\_ST Cross Street: HEWES\_ST Location: NW

ADA ID: RPAT210927154307 Ramp Type: Type 4 - Parallel Initial Pass/Fail: Fail Overall Compliance: No Severity Score: 4

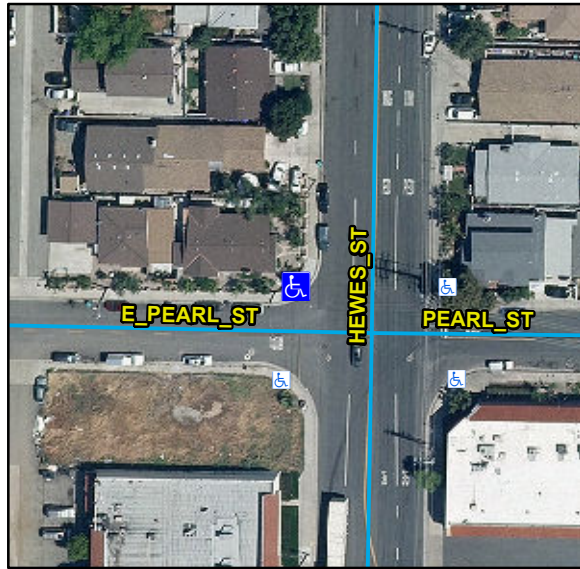
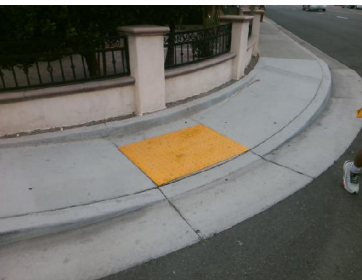
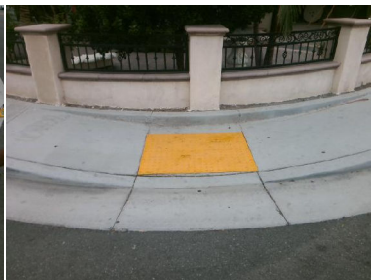
| Compliance | Description | Data | Compliance | Description | Data |
|---|---|---|---|---|---|
| No | Ramp Width LT (in) | 47 | No | Ramp Width RT (in) | 47 |

**Remove & Replace Curb Ramp With Two New Directional Ramps or Equivalent.**

**R304.5.1, STD 1115**
