# Access Compliance Report Public Rights-of-Way (Curb Ramps)

Main Street: RANCHO\_SANTIAGO\_BLVD Cross Street: SPRING\_ST Location: SW

ADA ID: RPAT210928091450 Ramp Type: Type 4 - Parallel Initial Pass/Fail: Fail Overall Compliance: No Severity Score: 20

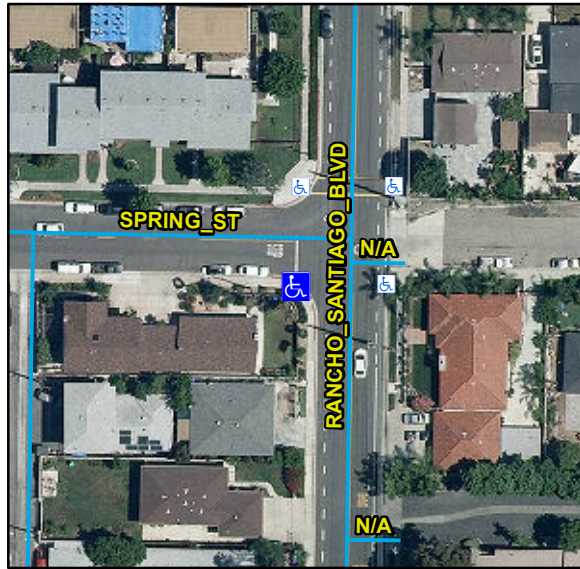
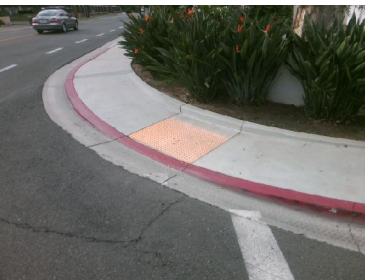
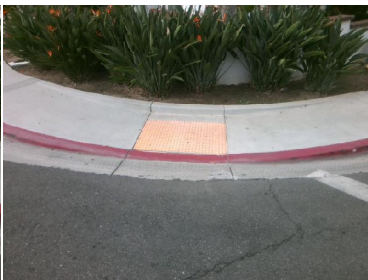
| Compliance | Description | Data | Compliance | Description | Data |
|---|---|---|---|---|---|
| No | Ramp Width LT (in) | 47 | No | Ramp Width RT (in) | 47 |
| No | Ramp Run Slope LT (%) | 10.1 | Yes | Ramp Run Slope RT (%) | 1 |
| Yes | Ramp Cross Slope LT (%) | 0 | No | Ramp Cross Slope RT (%) | 3.1 |

Remove & Replace Curb Ramp With Two New Directional Ramps or Equivalent.

R304.5.1, R304.3.2, R304.5.3, STD 1115
