# Access Compliance Report Public Rights-of-Way (Curb Ramps)

Main Street: RANCHO\_SANTIAGO\_BLVD Cross Street: E\_RYALS\_LN Location: NE

ADA ID: RPAT210928092658 Ramp Type: Type 1 - Perpendicular Diagonal Initial Pass/Fail: Pass Overall Compliance: No Severity Score: 4

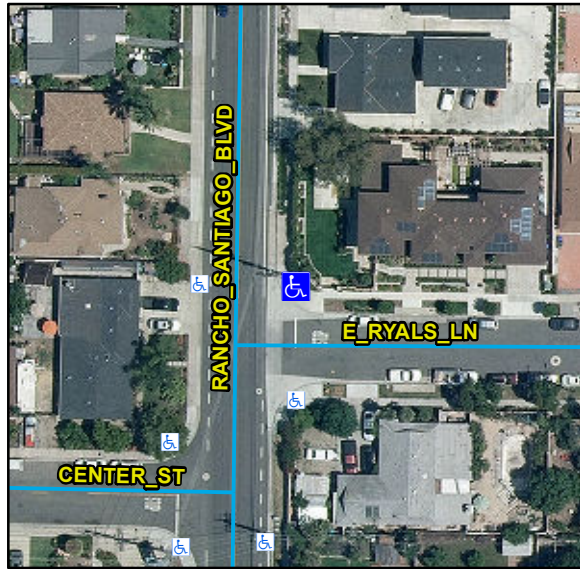
| Compliance | Description | Data | Compliance | Description | Data |
|---|---|---|---|---|---|
| N/A | Landing Movement Obstructed? | Yes | Yes | DWS Contrast | Yes |

Possible Solutions:

Remove & Replace Landing.

R304.2.1, STD 1115
