# Access Compliance Report Public Rights-of-Way (Curb Ramps)

Main Street: E\_RYALS\_LN Cross Street: RANCHO\_SANTIAGO\_BLVD Location: SE

ADA ID: RPAT210928093156 Ramp Type: Type 1 - Perpendicular Diagonal Initial Pass/Fail: Fail Overall Compliance: No Severity Score: 16

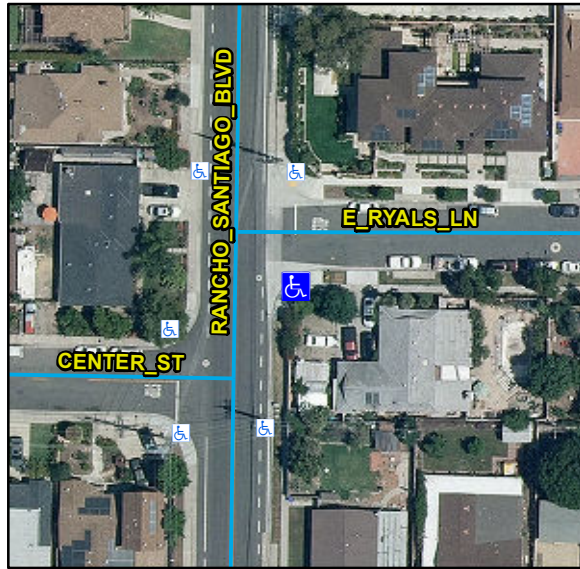
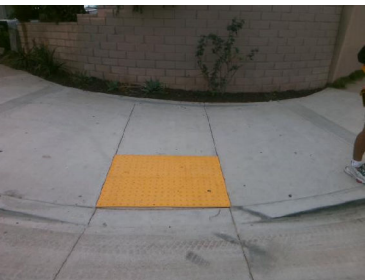
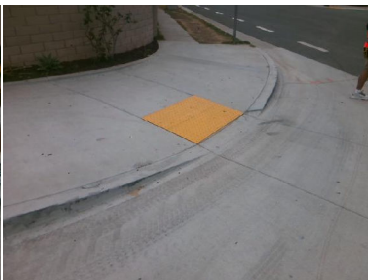
| Compliance | Description | Data | Compliance | Description | Data |
|---|---|---|---|---|---|
| No | Ramp Run Slope (%) | 9 | N/A | Flare Slope LT (%) | N/A |
| No | Ramp Cross Slope (%) | 2.3 | N/A | Flare Traversable LT | N/A |
| N/A | Gutter Ponding | N/A | No | Curb Slope | 12.6 |

Remove & Replace Curb Ramp With Two New Directional Ramps or Equivalent.

R304.2.2, R304.5.3, STD 1115
