# Access Compliance Report Public Rights-of-Way (Curb Ramps)

| Main Street: CENTER_ST | | Cross Street: RANCHO_SANTIAGO_BLVD | | Location: | NW |
| ADA ID: RPAT210928093512 | Ramp Type: Type 4 - Parallel | Initial Pass/Fail: Fail | Overall Compliance: No | Severity Score: | 4 |

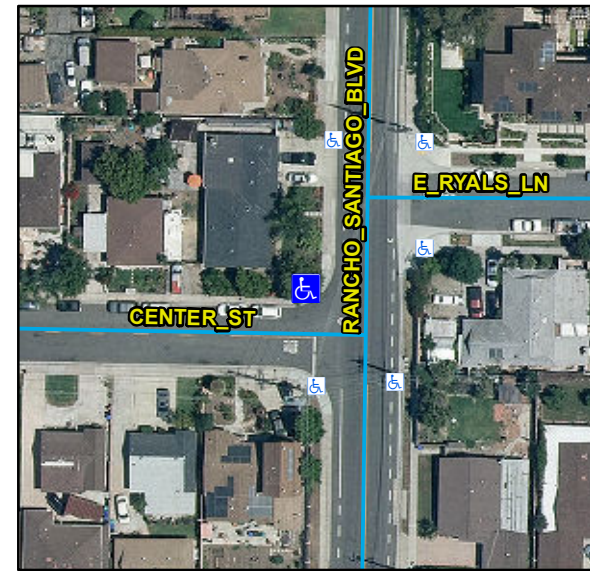
| Compliance | Description | Data | Compliance | Description | Data |
|---|---|---|---|---|---|
| Yes | Ramp Width LT (in) | 49 | No | Ramp Width RT (in) | 47 |

**Remove & Replace Curb Ramp With Two New Directional Ramps or Equivalent.**

**R304.5.1, STD 1115**

Total Cost: \$ 4000

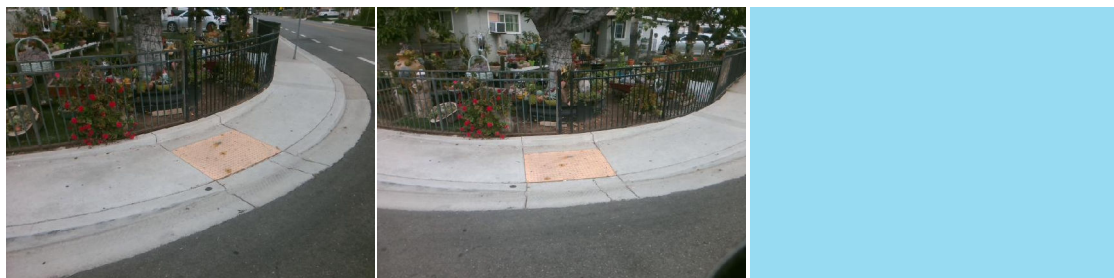
| Compliance | Description | Data | Compliance | Description | Data |
|---|---|---|---|---|---|
| N/A | Ramp Length LT (in) | 105 | N/A | Ramp Length RT (in) | 108 |
| Yes | Ramp Run Slope LT (%) | 0.3 | Yes | Ramp Run Slope RT (%) | 8.2 |
| Yes | Ramp Cross Slope LT (%) | 0.3 | Yes | Ramp Cross Slope RT (%) | 0.2 |
