# Access Compliance Report Public Rights-of-Way (Curb Ramps)

| Main Street: S_RANCHO_SANTIAGO_BLVD | | Cross Street: CENTER_ST | | Location: | SW |
| ADA ID: RPAT210928093823 | Ramp Type: Type 4 - Parallel | Initial Pass/Fail: Pass | Overall Compliance: No | Severity Score: | 25 |

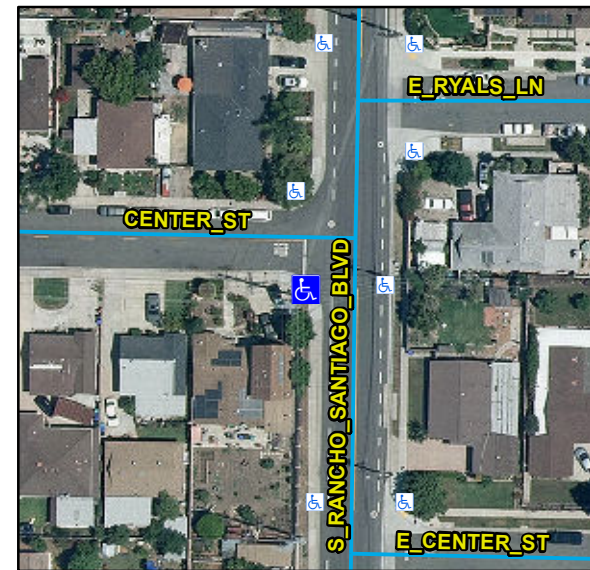
| Compliance | Description | Data | Compliance | Description | Data |
|---|---|---|---|---|---|
| No | Obstructions Present? | Yes | N/A | Utilities Present? | No |
| | Obstruction Types | Power Pole | | Utility Types | |

| Compliance | Description | Data | Compliance | Description | Data |
|---|---|---|---|---|---|
| No | Landing Cross Slope (%) | 5.5 | | DWS Offset Type | Single |
| No | Gutter Cross Slope (%) | 4.9 | Yes | Perpendicular Joint Present | Yes |

Remove & Replace Landing. Remove & Replace Gutter. Relocate Obstruction.
