# Access Compliance Report Public Rights-of-Way (Curb Ramps)

Main Street: E\_CENTER\_ST Cross Street: RANCHO\_SANTIAGO\_BLVD Location: SE

ADA ID: RPAT210928101411 Ramp Type: Type 1 - Perpendicular Diagonal Initial Pass/Fail: Pass Overall Compliance: No Severity Score: 4

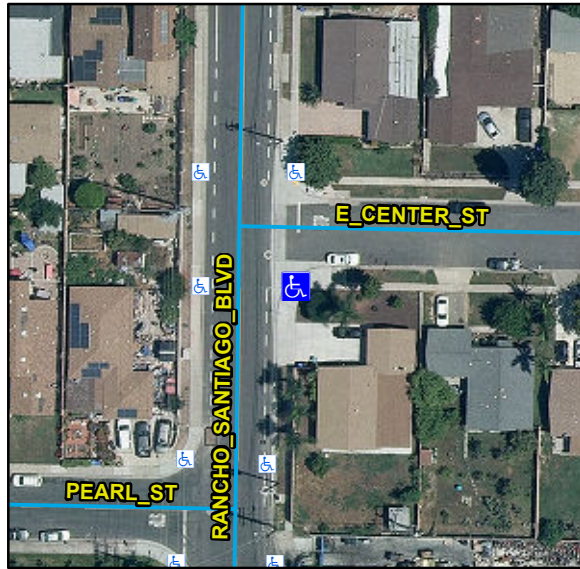
| Compliance | Description | Data | Compliance | Description | Data |
|---|---|---|---|---|---|
| N/A | Landing Length (in) | 44 | | | Sloped |
| N/A | Landing Movement Obstructed? | Yes | Yes | DWS Contrast | Yes |
| | Landing Movement Type | Curb | Yes | DWS Length (in) | 36 |

Possible Solutions:

Remove & Replace Landing.

R304.2.1, STD 1115
