# Access Compliance Report Public Rights-of-Way (Curb Ramps)

**Main Street:** PEARL\_ST **Cross Street:** RANCHO\_SANTIAGO\_BLV **Location:** NW

**ADA ID:** RPAT210928101812 **Ramp Type:** Type 4 - Parallel **Initial Pass/Fail:** Fail **Overall Compliance:** No **Severity Score:** 20

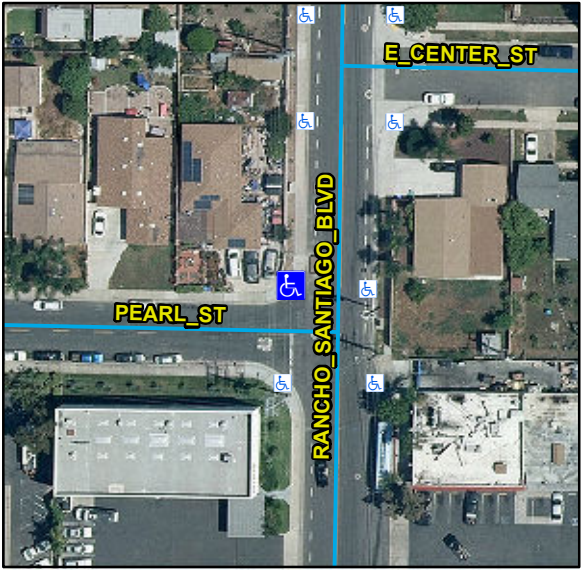
Compliance	Description	Data	Compliance	Description	Data
N/A	Ramp Length LT (in)	62	N/A	Ramp Length RT (in)	109
No	Ramp Width LT (in)	47	No	Ramp Width RT (in)	47
Yes	Ramp Run Slope LT (%)	4.3	No	Ramp Run Slope RT (%)	9.6
Yes	Ramp Cross Slope LT (%)	0	No	Ramp Cross Slope RT (%)	2.3
N/A	Landing Present	N/A	N/A	DWS Provided	N/A
N/A	Landing Length (in)	N/A	N/A	DWS Contrast	N/A
N/A	Landing Width (in)	N/A	N/A	DWS Length (in)	N/A
N/A	Landing Run Slope (%)	N/A	N/A	DWS Full Width	N/A
N/A	Landing Cross Slope (%)	N/A		DWS Offset Type	N/A
N/A	Landing Movement Obstructed?	N/A	N/A	DWS Offset Left (in)	N/A
	Landing Movement Type	N/A	N/A	DWS Offset Right (in)	N/A
N/A	Landing Shared	N/A			
N/A	Clear Space	Yes			
N/A	Clear Space To Crosswalk (in)	N/A			
N/A	Marked Crosswalk 1	No	N/A	Marked Crosswalk 2	No
	Crossing 1 Direction	S		Crossing 2 Direction	E
N/A	Marked Crosswalk 1 Width (in)	N/A	N/A	Marked Crosswalk 2 Width (in)	N/A

N/A	Ramp Inside Crosswalk 1	N/A	N/A	Ramp Inside Crosswalk 2	N/A
	Crossing 1 Slope (%)	7.2		Crossing 2 Slope (%)	5.6
	Crossing 1 Cross Slope (%)	6.9		Crossing 2 Cross Slope (%)	1
N/A	Gutter Ponding	N/A	N/A	Curb Slope	3.2
Yes	Gutter Lip Height (in)	0		Road Run Slope (%)	4.8
N/A	Gutter Run Slope (%)	N/A		Road Cross Slope (%)	5.8
N/A	Gutter Cross Slope (%)	N/A	Yes	Perpendicular Joint Present	Yes
Yes	Overall Surface Condition	Acceptable			
	Cross Gutter Present?	No		Spandrel Present?	No
	Replace Cross Gutter?	N/A		Replace Spandrel?	N/A

**Possible Solutions:**  
**Remove & Replace Curb Ramp With Two New Directional Ramps or Equivalent.**

**OC Std/PROW:**  
 R304.5.1, R304.3.2, R304.5.3, STD 1115

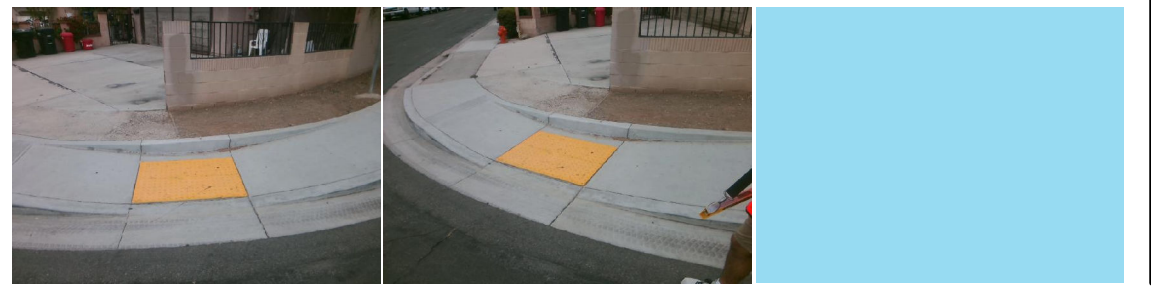
Compliance	Description	Data	Compliance	Description	Data
Yes	Obstructions Present?	No	N/A	Utilities Present?	No
	Obstruction Types	N/A		Utility Types	
	Obstruction Dimensions	N/A			N/A
