# Access Compliance Report Public Rights-of-Way (Curb Ramps)

| Main Street: RANCHO_SANTIAGO_BLVD | | Cross Street: PEARL_ST | | Location: | SW |
| ADA ID: RPAT210928102250 | Ramp Type: Type 4 - Parallel | Initial Pass/Fail: Pass | Overall Compliance: No | Severity Score: | 25 |

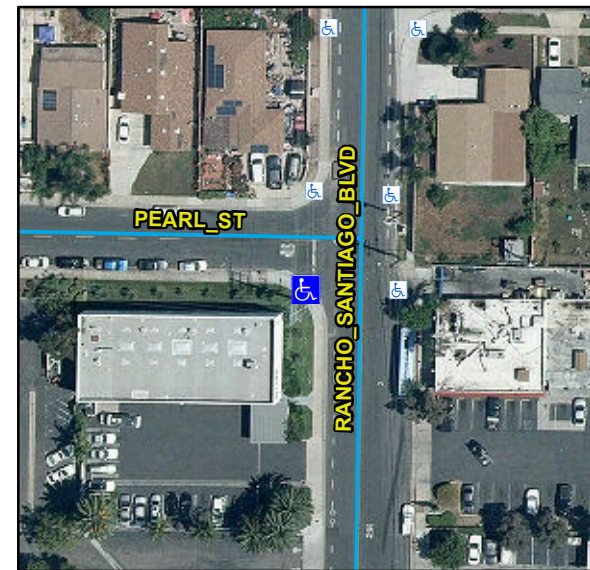
| Compliance | Description | Data | Compliance | Description | Data |
|---|---|---|---|---|---|
| No | Obstructions Present? | Yes | N/A | Utilities Present? | No |
| | Obstruction Types | Power Pole | | Utility Types | |

| Compliance | Description | Data | Compliance | Description | Data |
|---|---|---|---|---|---|
| Yes | Gutter Ponding | No | No | Curb Slope | 10 |
| No | Gutter Run Slope (%) | 9.5 | | Road Cross Slope (%) | 2.3 |
| No | Gutter Cross Slope (%) | 4.2 | Yes | Perpendicular Joint Present | Yes |

**Remove & Replace Curb Slope. Remove & Replace Gutter. Relocate Obstruction.**

**R304.2.2, R304.5.4, R304.5.3, R302.3, R402.2, STD 1115**
