# Access Compliance Report Public Rights-of-Way (Curb Ramps)

Main Street: E\_RYALS\_LN Cross Street: N\_RENEE\_ST Location: NW

ADA ID: RPAT210928104221 Ramp Type: Type 1 - Perpendicular Diagonal Initial Pass/Fail: Fail Overall Compliance: No Severity Score: 2

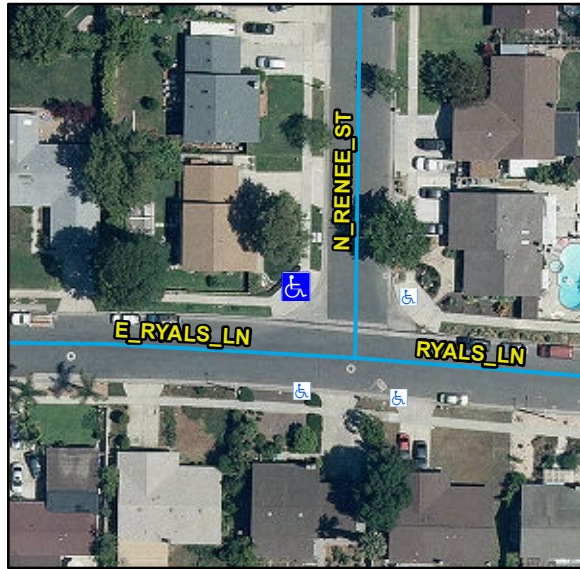
R304.2.2, R304.5.3, STD 1115

| Compliance | Description | Data | Compliance | Description | Data |
|---|---|---|---|---|---|
| No | Ramp Cross Slope (%) | 2.2 | N/A | Flare Traversable LT | N/A |

Remove & Replace Curb Ramp With Two New Directional Ramps or Equivalent.
