# Access Compliance Report Public Rights-of-Way (Curb Ramps)

Main Street: VINE\_ST Cross Street: HEWES\_ST Location: SE

ADA ID: RPAT210928124736 Ramp Type: Type 4 - Parallel Initial Pass/Fail: Fail Overall Compliance: No Severity Score: 4

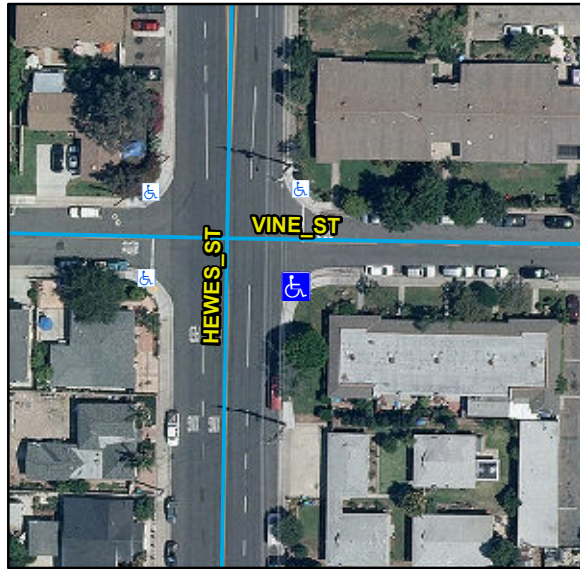
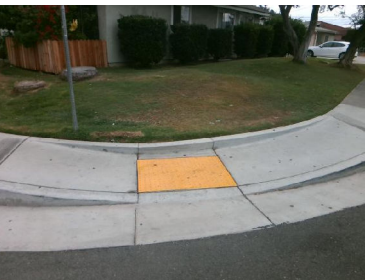
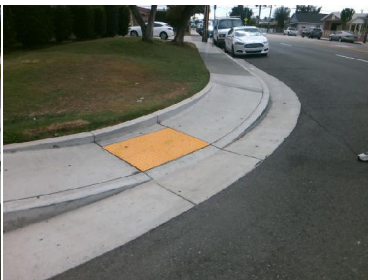
| Compliance | Description | Data | Compliance | Description | Data |
|---|---|---|---|---|---|
| N/A | Ramp Length LT (in) | 68 | N/A | Ramp Length RT (in) | 115 |
| No | Ramp Width LT (in) | 45 | Yes | Ramp Width RT (in) | 48 |

**Remove & Replace Curb Ramp With Two New Directional Ramps or Equivalent.**

**R304.5.1, STD 1115**

Total Cost: \$ 4000
