# Access Compliance Report Public Rights-of-Way (Curb Ramps)

Main Street: HEWES\_ST Cross Street: VINE\_ST Location: NE

ADA ID: RPAT210928125135 Ramp Type: Type 4 - Parallel Initial Pass/Fail: Fail Overall Compliance: No Severity Score: 2

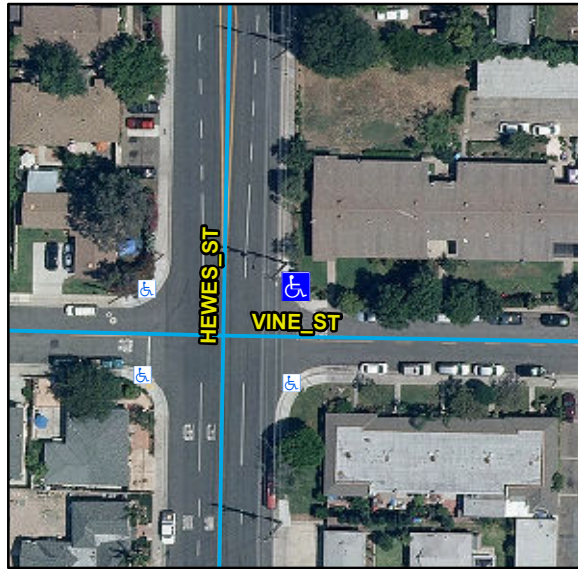
| Compliance | Description | Data | Compliance | Description | Data |
|---|---|---|---|---|---|
| Yes | Ramp Cross Slope LT (%) | 0.3 | No | Ramp Cross Slope RT (%) | 2.1 |

**Remove & Replace Curb Ramp With Two New Directional Ramps or Equivalent.**

**R304.5.3, STD 1115**
