# Access Compliance Report Public Rights-of-Way (Curb Ramps)

Main Street: E\_SILVERLEAF\_AVE Cross Street: HEWES\_ST Location: SE

ADA ID: RPAT210928131346 Ramp Type: Type 1 - Perpendicular Diagonal Initial Pass/Fail: Pass Overall Compliance: No Severity Score: 6

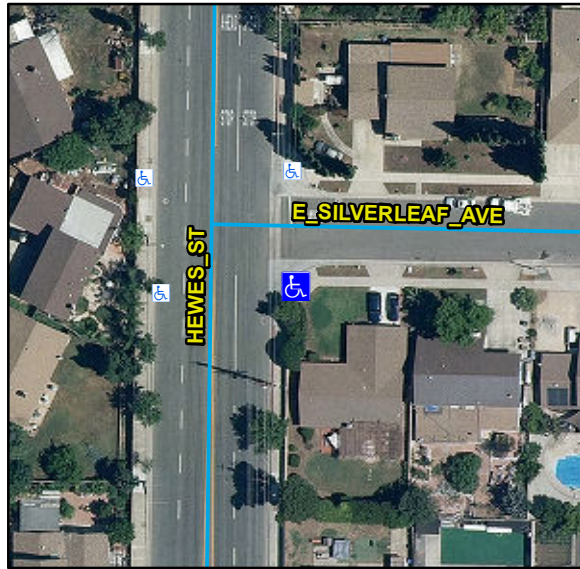
| Compliance | Description | Data | Compliance | Description | Data |
|---|---|---|---|---|---|
| No | Landing Run Slope (%) | 2.9 | N/A | Flare Traversable RT | Yes |
| No | Landing Cross Slope (%) | 2.7 | Yes | DWS Provided | Yes |
| Yes | Gutter Ponding | No | No | Curb Slope | 14.8 |

Remove & Replace Curb Ramp With Two New Directional Ramps or Equivalent.
