# Access Compliance Report Public Rights-of-Way (Curb Ramps)

Main Street: E\_WALNUT\_AVE Cross Street: N\_HEWES\_ST Location: SE

ADA ID: RPAT210928132508 Ramp Type: Type 4 - Parallel Initial Pass/Fail: Fail Overall Compliance: No Severity Score: 15

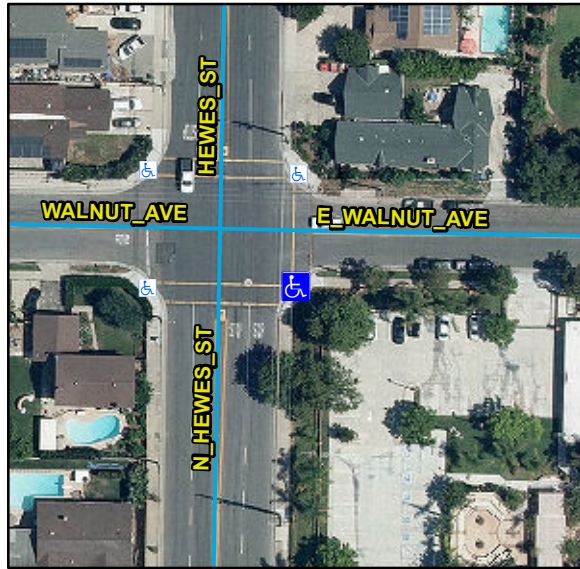
| Compliance | Description | Data | Compliance | Description | Data |
|---|---|---|---|---|---|
| No | Ramp Run Slope LT (%) | 9.3 | Yes | Ramp Run Slope RT (%) | 6.6 |

**Remove & Replace Curb Ramp With Two New Directional Ramps or Equivalent.**

**R304.3.2, STD 1115**
