# Access Compliance Report Public Rights-of-Way (Curb Ramps)

Main Street: HEWES\_ST Cross Street: E\_WALNUT\_AVE Location: NE

ADA ID: RPAT210928132754 Ramp Type: Type 1 - Perpendicular Diagonal Initial Pass/Fail: Pass Overall Compliance: No Severity Score: 0

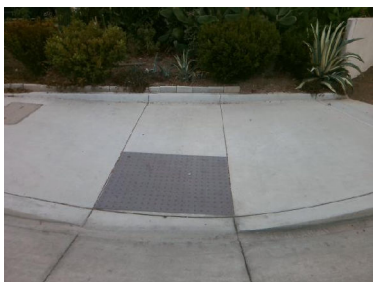
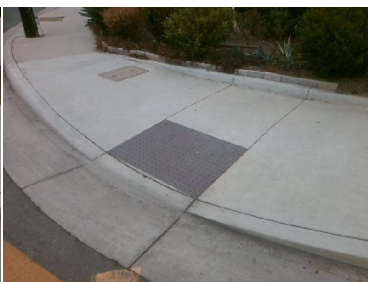
| Compliance | Description | Data | Compliance | Description | Data |
|---|---|---|---|---|---|
| Yes | Gutter Ponding | No | No | Curb Slope | 11.5 |

**Remove & Replace Curb Ramp With Two New Directional Ramps or Equivalent. Utility Present.**
