# Access Compliance Report Public Rights-of-Way (Curb Ramps)

Main Street: WALNUT\_AVE Cross Street: HEWES\_ST Location: NW

ADA ID: RPAT210928133207 Ramp Type: Type 4 - Parallel Initial Pass/Fail: Pass Overall Compliance: No Severity Score: 0

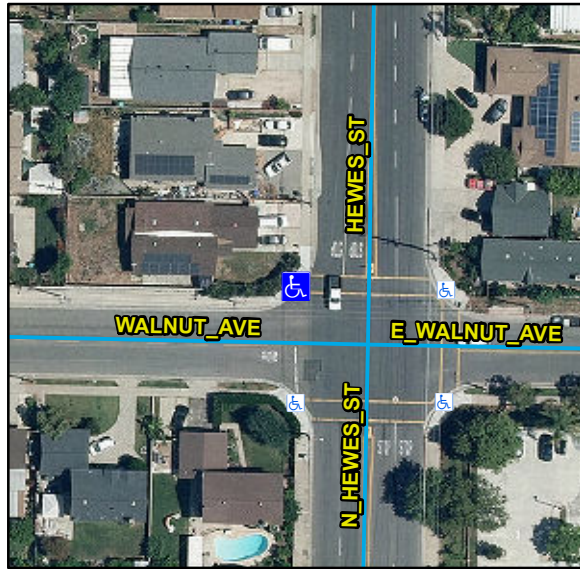
| Compliance | Description | Data | Compliance | Description | Data |
|---|---|---|---|---|---|
| Yes | Gutter Ponding | No | No | Curb Slope | 11.2 |

Remove & Replace Curb Slope. Restripe Crosswalk.

R304.2.2, R207.1, STD 1115
