# Access Compliance Report Public Rights-of-Way (Curb Ramps)

Main Street: N\_HEWES\_ST Cross Street: WALNUT\_AVE Location: SW

ADA ID: RPAT210928133814 Ramp Type: Type 4 - Parallel Initial Pass/Fail: Fail Overall Compliance: No Severity Score: 2

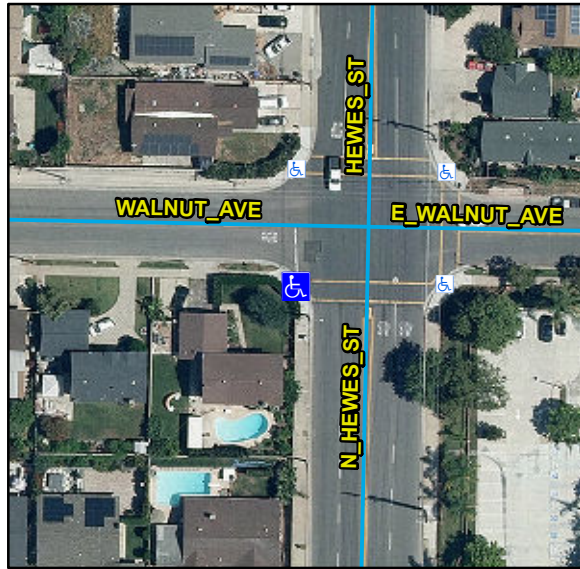
| Compliance | Description | Data | Compliance | Description | Data |
|---|---|---|---|---|---|
| No | Ramp Cross Slope LT (%) | 3.3 | Yes | Ramp Cross Slope RT (%) | 0 |

**Remove & Replace Curb Ramp With Two New Directional Ramps or Equivalent.**

**R304.5.3, STD 1115**
