# Access Compliance Report Public Rights-of-Way (Curb Ramps)

Main Street: E\_EUCLID\_AVE Cross Street: N\_HEWES\_ST Location: NW

ADA ID: RPAT210928134206 Ramp Type: Type 1 - Perpendicular Diagonal Initial Pass/Fail: Fail Overall Compliance: No Severity Score: 5

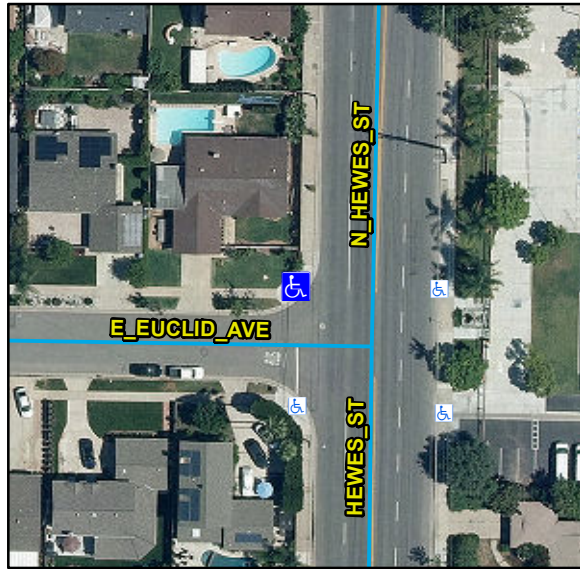
| Compliance | Description | Data | Compliance | Description | Data |
|---|---|---|---|---|---|
| No | Ramp Width (in) | 47 | | | N/A |
| No | Ramp Cross Slope (%) | 3.1 | N/A | Flare Traversable LT | N/A |

Remove & Replace Curb Ramp With Two New Directional Ramps or Equivalent.

R304.5.1, R304.5.3, STD 1115
