# Access Compliance Report Public Rights-of-Way (Curb Ramps)

Main Street: HEWES\_ST Cross Street: E\_EUCLID\_AVE Location: SW

ADA ID: RPAT210928134439 Ramp Type: Type 1 - Perpendicular Diagonal Initial Pass/Fail: Fail Overall Compliance: No Severity Score: 2

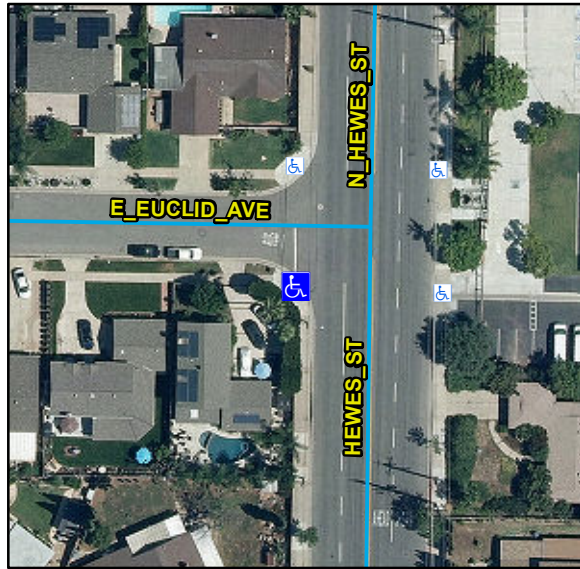
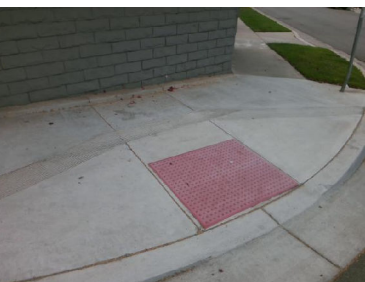
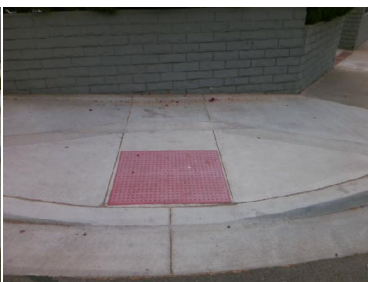
R304.2.2, R304.5.3, STD 1115

| Compliance | Description | Data | Compliance | Description | Data |
|---|---|---|---|---|---|
| No | Ramp Cross Slope (%) | 3.5 | N/A | Flare Traversable LT | N/A |

Remove & Replace Curb Ramp With Two New Directional Ramps or Equivalent.
