# Access Compliance Report Public Rights-of-Way (Curb Ramps)

Main Street: HEWES\_ST Cross Street: E\_SYCAMORE\_AVE Location: SW

ADA ID: RPAT210929090350 Ramp Type: Type 4 - Parallel Initial Pass/Fail: Fail Overall Compliance: No Severity Score: 15

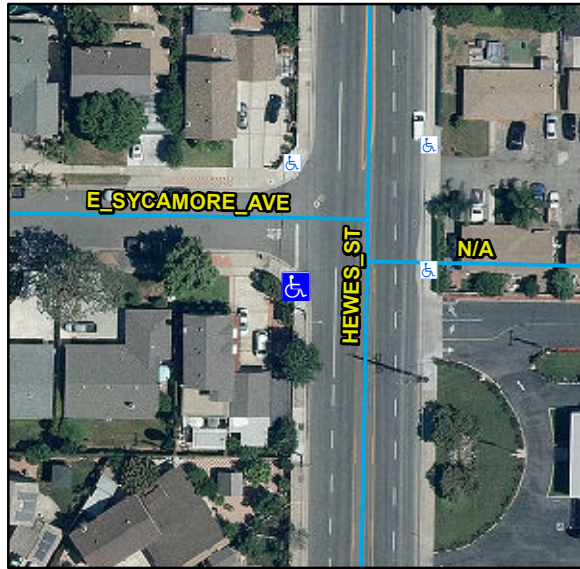
| Compliance | Description | Data | Compliance | Description | Data |
|---|---|---|---|---|---|
| No | Ramp Run Slope LT (%) | 12 | Yes | Ramp Run Slope RT (%) | 3.6 |

**Remove & Replace Curb Ramp With Two New Directional Ramps or Equivalent.**

**R304.3.2, STD 1115**

Total Cost: \$ 4000
