# Access Compliance Report Public Rights-of-Way (Curb Ramps)

Main Street: E\_SPRING\_ST Cross Street: HEWES\_ST Location: NW

ADA ID: RPAT210929091118 Ramp Type: Type 1 - Perpendicular Diagonal Initial Pass/Fail: Fail Overall Compliance: No Severity Score: 4

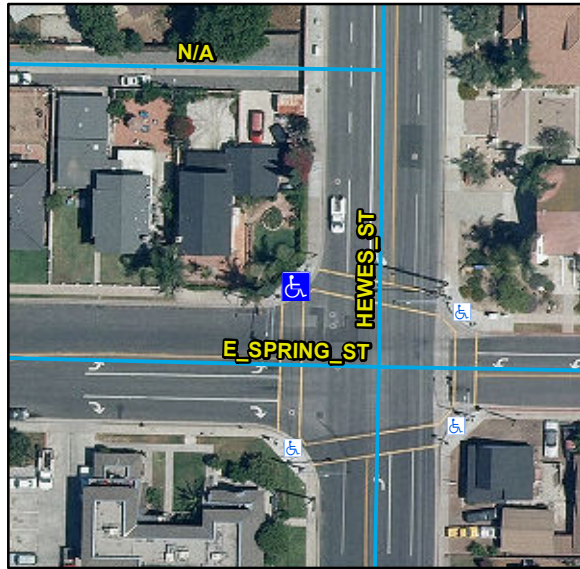
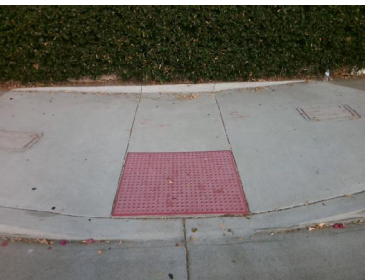
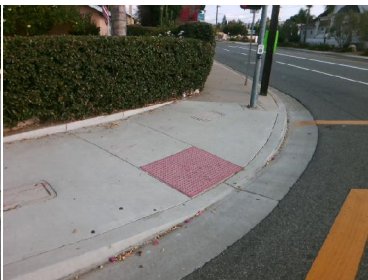
| Compliance | Description | Data | Compliance | Description | Data |
|---|---|---|---|---|---|
| No | Ramp Width (in) | 47 | | | N/A |

**Remove & Replace Curb Ramp With Two New Directional Ramps or Equivalent.**

**R304.5.1, STD 1115**
