# Access Compliance Report Public Rights-of-Way (Curb Ramps)

Main Street: VINE\_ST Cross Street: HEWES\_ST Location: NW

ADA ID: RPAT210929092334 Ramp Type: Type 4 - Parallel Initial Pass/Fail: Fail Overall Compliance: No Severity Score: 19

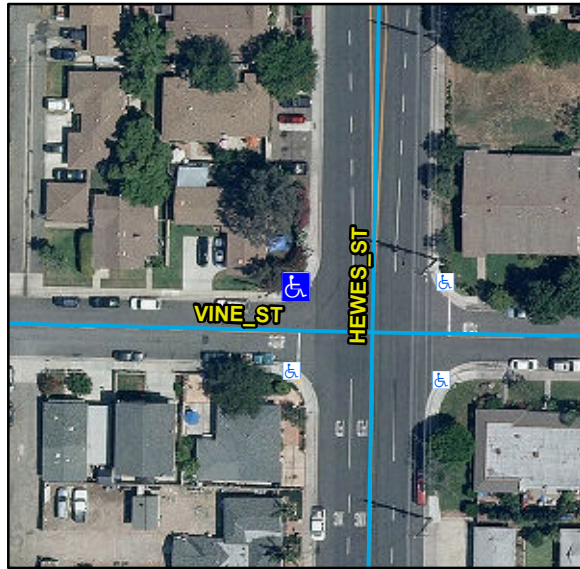
| Compliance | Description | Data | Compliance | Description | Data |
|---|---|---|---|---|---|
| Yes | Ramp Width LT (in) | 48 | No | Ramp Width RT (in) | 47 |
| Yes | Ramp Run Slope LT (%) | 0.2 | No | Ramp Run Slope RT (%) | 8.9 |

**Remove & Replace Curb Ramp With Two New Directional Ramps or Equivalent.**

**R304.5.1, R304.3.2, STD 1115**
