# Access Compliance Report Public Rights-of-Way (Curb Ramps)

Main Street: HEWES\_ST Cross Street: VINE\_ST Location: SW

ADA ID: RPAT210929092610 Ramp Type: Type 4 - Parallel Initial Pass/Fail: Pass Overall Compliance: No Severity Score: 6

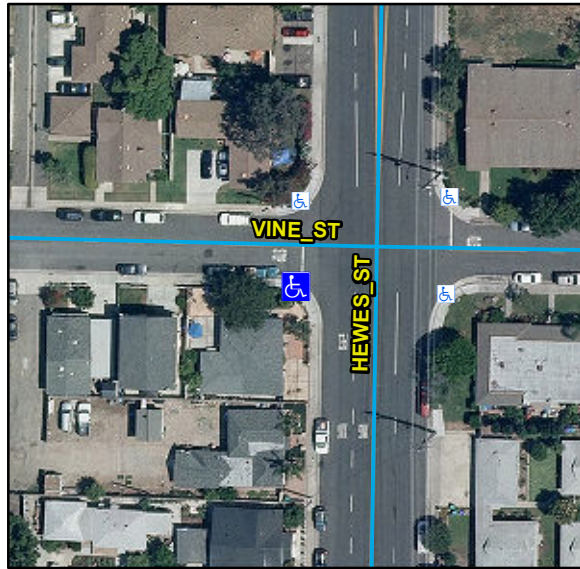
| Compliance | Description | Data | Compliance | Description | Data |
|---|---|---|---|---|---|
| No | Landing Cross Slope (%) | 4.1 | | DWS Offset Type | Single |
| No | Gutter Run Slope (%) | 5.9 | | Road Cross Slope (%) | 5.7 |
| No | Gutter Cross Slope (%) | 4.9 | Yes | Perpendicular Joint Present | Yes |

**Remove & Replace Landing. Remove & Replace Gutter.**
