# Access Compliance Report Public Rights-of-Way (Curb Ramps)

| Main Street: HEWES_ST | Cross Street: PEARL_ST | Location: NE |

| ADA ID: RPAT210929095836 | Ramp Type: Type 4 - Parallel | Initial Pass/Fail: Fail | Overall Compliance: No | Severity Score: 15 |

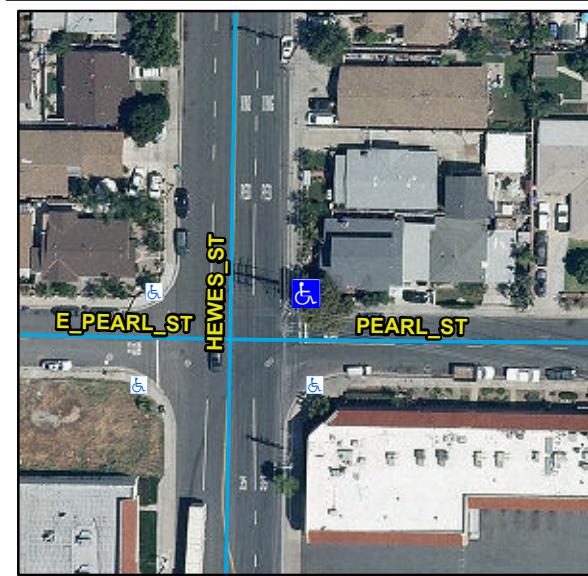
| Compliance | Description | Data | Compliance | Description | Data |
|---|---|---|---|---|---|
| No | Obstructions Present? | Yes | N/A | Utilities Present? | Yes |
| | Obstruction Types | Power Pole | | Utility Types | |

| Compliance | Description | Data | Compliance | Description | Data |
|---|---|---|---|---|---|
| No | Ramp Run Slope LT (%) | 8.4 | Yes | Ramp Run Slope RT (%) | 6.4 |

Possible Solutions:

**Remove & Replace Curb Ramp With Two New Directional Ramps or Equivalent.**

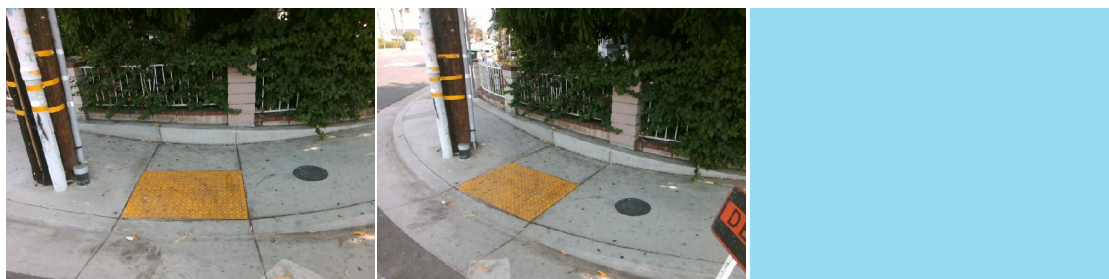
| Compliance | Description | Data | Compliance | Description | Data |
|---|---|---|---|---|---|
| | Obstruction Dimensions | N/A | | Water Valve | |
