# Access Compliance Report Public Rights-of-Way (Curb Ramps)

Main Street: PEARL\_ST Cross Street: HEWES\_ST Location: SE

ADA ID: RPAT210929102234 Ramp Type: Type 1 - Perpendicular Diagonal Initial Pass/Fail: Fail Overall Compliance: No Severity Score: 19

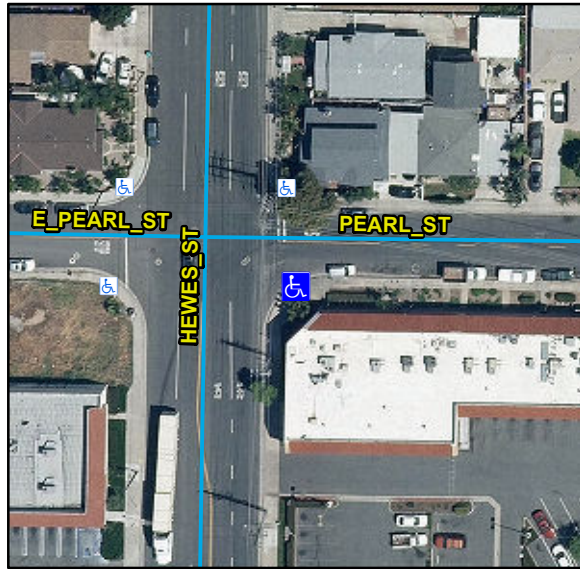
| Compliance | Description | Data | Compliance | Description | Data |
|---|---|---|---|---|---|
| No | Ramp Width (in) | 46 | | | N/A |
| No | Ramp Run Slope (%) | 10 | N/A | Flare Slope LT (%) | N/A |

Remove & Replace Curb Ramp With Two New Directional Ramps or Equivalent.

R304.5.1, R304.2.2, STD 1115
