# Access Compliance Report Public Rights-of-Way (Curb Ramps)

Main Street: RANCHO\_SANTIAGO\_BLV D Cross Street: E\_CHAPMAN\_AVE Location: NE

ADA ID: RPAT210929105021 Ramp Type: Type 4 - Parallel Initial Pass/Fail: Fail Overall Compliance: No Severity Score: 15

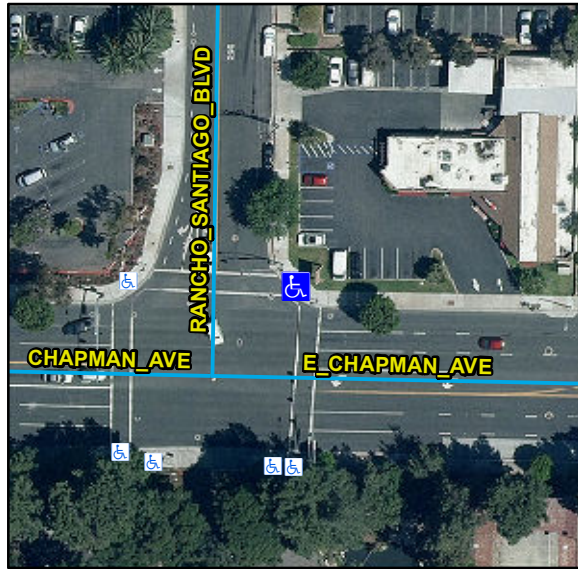
| Compliance | Description | Data | Compliance | Description | Data |
|---|---|---|---|---|---|
| Yes | Ramp Run Slope LT (%) | 4.1 | No | Ramp Run Slope RT (%) | 9.2 |

Remove & Replace Curb Ramp With Two New Directional Ramps or Equivalent.

R304.3.2, STD 1115
