# Access Compliance Report Public Rights-of-Way (Curb Ramps)

| Main Street: E_CHAPMAN_AVE | | Cross Street: RANCHO_SANTIAGO_BLVD | | Location: | SE |
| ADA ID: RPAT210929110134 | Ramp Type: Type 4 - Parallel | Initial Pass/Fail: Fail | Overall Compliance: No | Severity Score: | 15 |

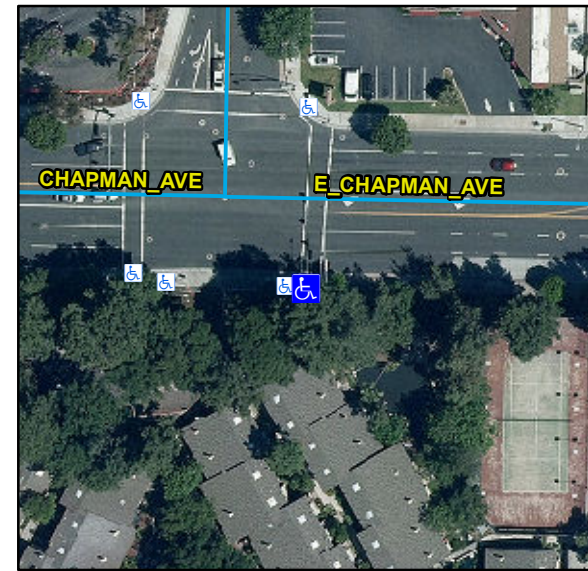
| Compliance | Description | Data | Compliance | Description | Data |
|---|---|---|---|---|---|
| No | Ramp Run Slope LT (%) | 9.4 | Yes | Ramp Run Slope RT (%) | 7 |

Possible Solutions:

Remove & Replace Entire Ramp.

R304.3.2, STD 1115

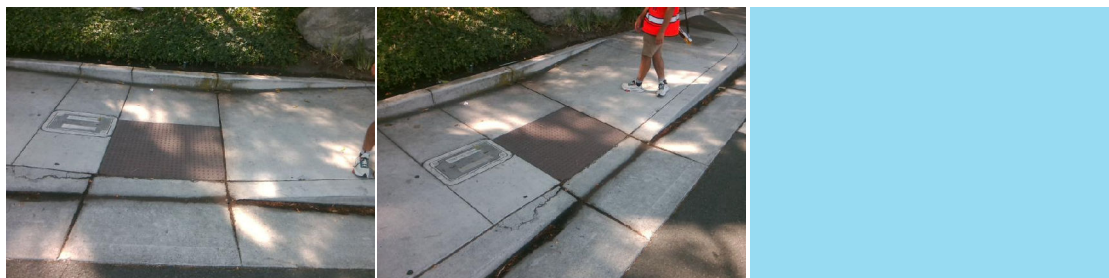
| Compliance | Description | Data | Compliance | Description | Data |
|---|---|---|---|---|---|
| Yes | Obstructions Present? | No | N/A | Utilities Present? | Yes |
| | Obstruction Dimensions | N/A | | Pull Box | |
