# Access Compliance Report Public Rights-of-Way (Curb Ramps)

| Main Street: CHAPMAN_AVE | | Cross Street: RANCHO_SANTIAGO_BLVD | | Location: | SW |
| ADA ID: RPAT210929124617 | Ramp Type: Type 4 - Parallel | Initial Pass/Fail: Pass | Overall Compliance: No | Severity Score: | 5 |

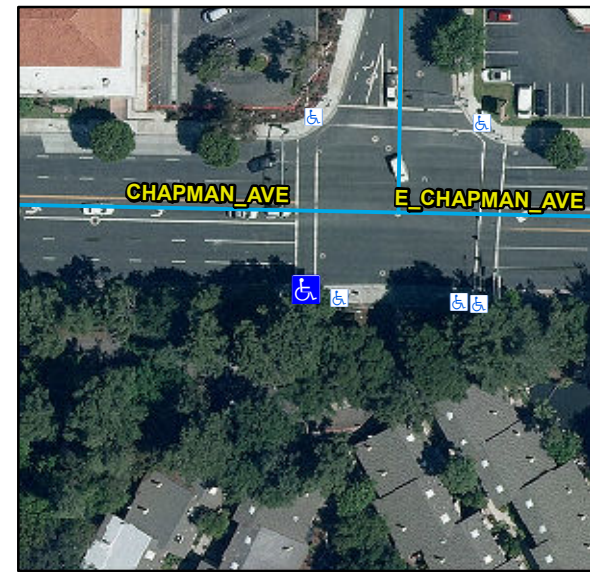
R304.5.4, STD 1115

| Compliance | Description | Data | Compliance | Description | Data |
|---|---|---|---|---|---|
| No | Gutter Run Slope (%) | 7.9 | | Road Cross Slope (%) | N/A |

Possible Solutions:

Remove & Replace Gutter.

Total Cost: \$ 252

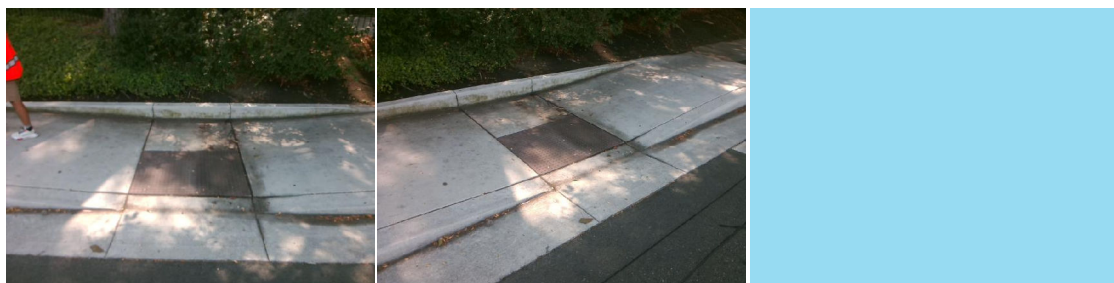
| Compliance | Description | Data | Compliance | Description | Data |
| N/A | Ramp Length LT (in) | 120 | N/A | Ramp Length RT (in) | 110 |
| Yes | Ramp Width LT (in) | 78 | Yes | Ramp Width RT (in) | 79 |
| Yes | Ramp Run Slope LT (%) | 7.5 | Yes | Ramp Run Slope RT (%) | 6.6 |
| Yes | Ramp Cross Slope LT (%) | 0.7 | Yes | Ramp Cross Slope RT (%) | 0.2 |
