# Access Compliance Report Public Rights-of-Way (Curb Ramps)

Main Street: CHAPMAN\_AVE Cross Street: RANCHO\_SANTIAGO\_BLVD Location: SW

ADA ID: RPAT210929125633 Ramp Type: Type 7 - Directional 2 Initial Pass/Fail: Pass Overall Compliance: No Severity Score: 9

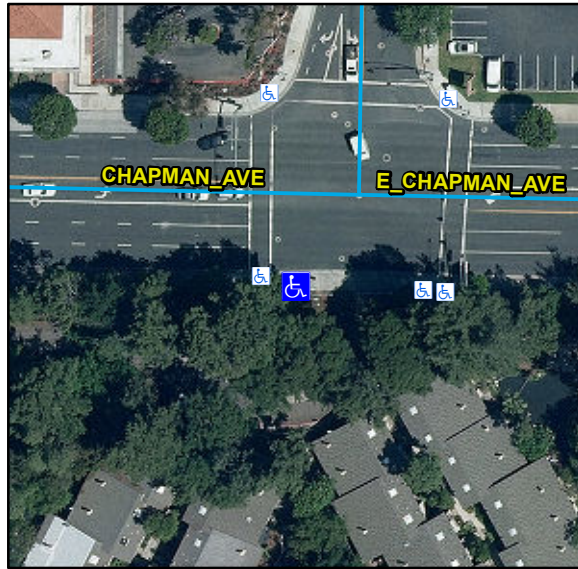
| Compliance | Description | Data | Compliance | Description | Data |
|---|---|---|---|---|---|
| No | Landing Length (in) | 42 | Yes | DWS Length (in) | 60 |
| No | Gutter Run Slope (%) | 7.4 | | Road Cross Slope (%) | N/A |
| No | Gutter Cross Slope (%) | 5.7 | | Parallel Ramp Side | Left |

Remove & Replace Landing. Remove & Replace Gutter. Utility Present.

R304.2.1, R304.5.4, R304.5.3, STD 1115
