# Access Compliance Report Public Rights-of-Way (Curb Ramps)

Main Street: **S\_SERANADO\_ST** Cross Street: **E\_CHAPMAN\_AVE** Location: **SW**

ADA ID: **RPAT210929141451** Ramp Type: **Type 4 - Parallel** Initial Pass/Fail: **Fail** Overall Compliance: **No** Severity Score: **16**

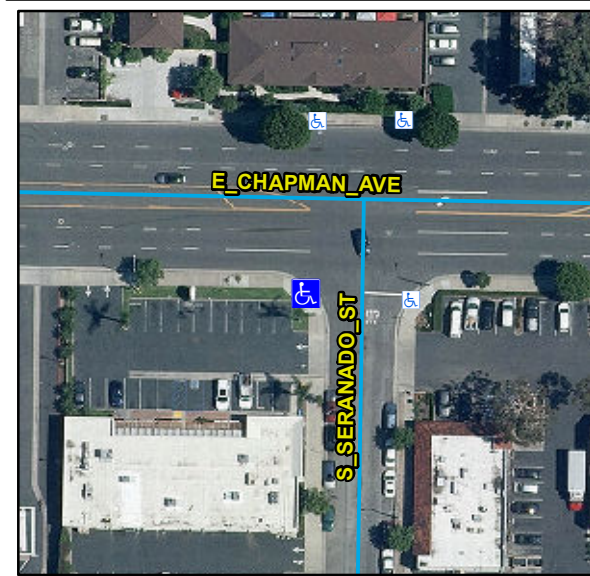
| Compliance | Description | Data | Compliance | Description | Data |
|---|---|---|---|---|---|
| <b>Yes</b> | Ramp Run Slope LT (%) | <b>6.8</b> | <b>No</b> | Ramp Run Slope RT (%) | <b>9.6</b> |
| <b>No</b> | Ramp Cross Slope LT (%) | <b>2.7</b> | <b>Yes</b> | Ramp Cross Slope RT (%) | <b>1.2</b> |

**Remove & Replace Curb Ramp With Two New Directional Ramps or Equivalent.**

**R304.5.3, R304.3.2, STD 1115**
