# Access Compliance Report Public Rights-of-Way (Curb Ramps)

Main Street: E\_CHAPMAN\_AVE Cross Street: S\_SERANADO\_ST Location: SE

ADA ID: RPAT210929142014 Ramp Type: Type 4 - Parallel Initial Pass/Fail: Fail Overall Compliance: No Severity Score: 15

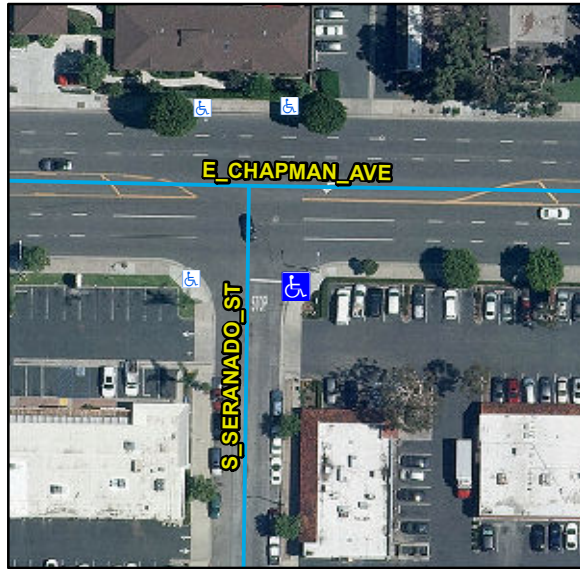
| Compliance | Description | Data | Compliance | Description | Data |
|---|---|---|---|---|---|
| No | Ramp Run Slope LT (%) | 10.8 | No | Ramp Run Slope RT (%) | 8.8 |
| No | Gutter Lip Height (in) | 1 | | Road Run Slope (%) | 3.2 |

**Remove & Replace Curb Ramp With Two New Directional Ramps or Equivalent. Grind Gutter Lip.**

**R304.3.2, R302.7.2, STD 1115**

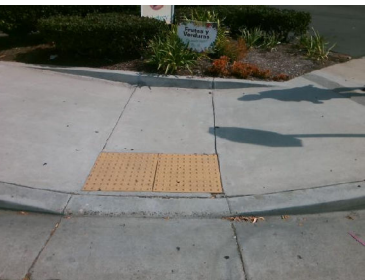
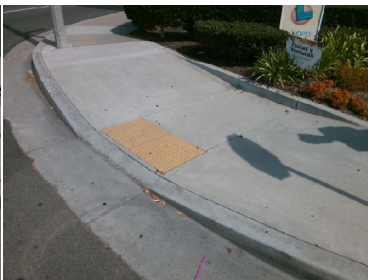
| Compliance | Description | Data | Compliance | Description | Data |
|---|---|---|---|---|---|
| N/A | Ramp Length LT (in) | 99 | N/A | Ramp Length RT (in) | 70 |
| Yes | Ramp Width LT (in) | 102 | Yes | Ramp Width RT (in) | 93 |
| Yes | Ramp Cross Slope LT (%) | 0.7 | Yes | Ramp Cross Slope RT (%) | 1.5 |
