# Access Compliance Report Public Rights-of-Way (Curb Ramps)

Main Street: ESPLANADE\_ST Cross Street: E\_CENTURY\_DR Location: NE

ADA ID: RPAT210929142856 Ramp Type: Type 4 - Parallel Initial Pass/Fail: Fail Overall Compliance: No Severity Score: 4

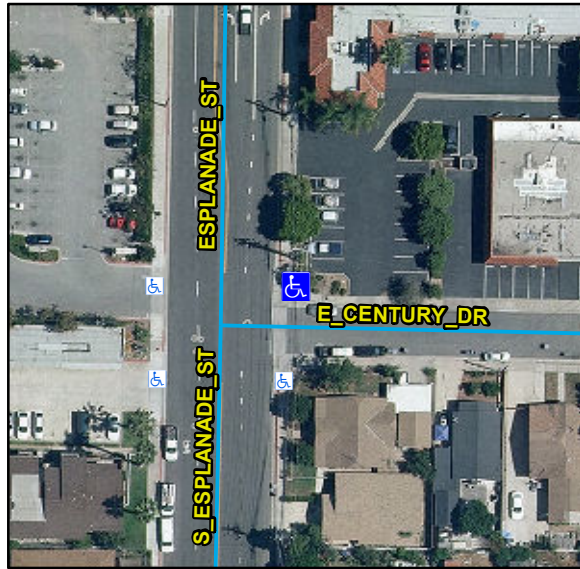
| Compliance | Description | Data | Compliance | Description | Data |
|---|---|---|---|---|---|
| No | Ramp Width LT (in) | 44 | No | Ramp Width RT (in) | 43 |

**Remove & Replace Curb Ramp With Two New Directional Ramps or Equivalent.**

**R304.5.1, STD 1115**
