# Access Compliance Report Public Rights-of-Way (Curb Ramps)

Main Street: E\_CENTURY\_DR Cross Street: S\_ESPLANADE\_ST Location: SE

ADA ID: RPAT210929143240 Ramp Type: Type 4 - Parallel Initial Pass/Fail: Fail Overall Compliance: No Severity Score: 4

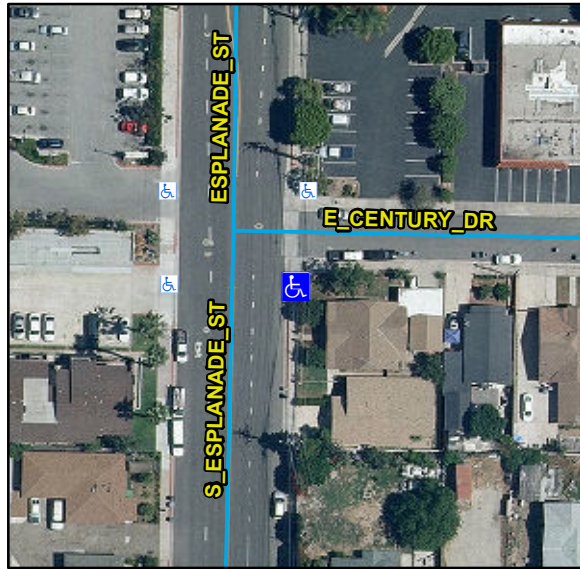
| Compliance | Description | Data | Compliance | Description | Data |
|---|---|---|---|---|---|
| No | Ramp Width LT (in) | 46 | No | Ramp Width RT (in) | 46 |

**Remove & Replace Curb Ramp With Two New Directional Ramps or Equivalent.**

**R304.5.1, STD 1115**
