# Access Compliance Report Public Rights-of-Way (Curb Ramps)

| Main Street: WASHINGTON_AVE | | Cross Street: EARLHAM_ST | | Location: | NW |
| ADA ID: RPAT210929144747 | Ramp Type: Type 4 - Parallel | Initial Pass/Fail: Fail | Overall Compliance: No | Severity Score: | 5 |

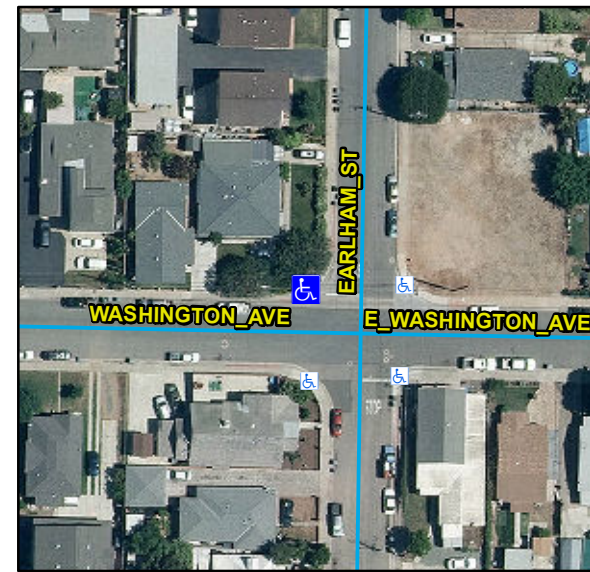
| Compliance | Description | Data | Compliance | Description | Data |
|---|---|---|---|---|---|
| No | Ramp Width LT (in) | 46 | No | Ramp Width RT (in) | 46 |
| No | Ramp Cross Slope LT (%) | 2.9 | No | Ramp Cross Slope RT (%) | 2.6 |

**Remove & Replace Curb Ramp With Two New Directional Ramps or Equivalent. Replace Spandrel.**

**R304.5.1, R304.5.3, STD 122-2, STD 1115**

Total Cost: \$ 6950
