# Access Compliance Report Public Rights-of-Way (Curb Ramps)

Main Street: E\_WASHINGTON\_AVE Cross Street: EARLHAM\_ST Location: SE

ADA ID: RPAT210929145748 Ramp Type: Type 4 - Parallel Initial Pass/Fail: Fail Overall Compliance: No Severity Score: 16

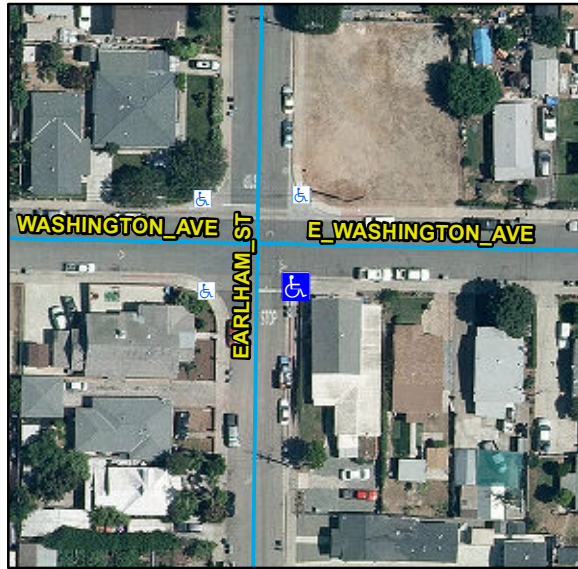
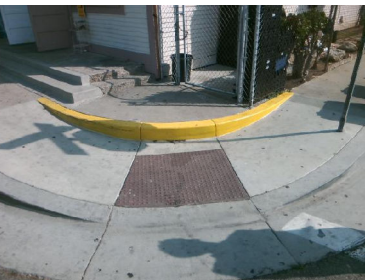
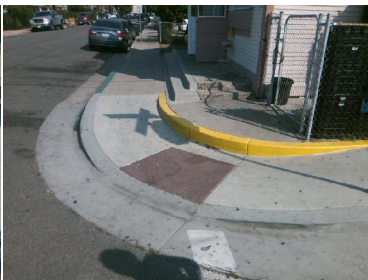
| Compliance | Description | Data | Compliance | Description | Data |
|---|---|---|---|---|---|
| No | Ramp Run Slope LT (%) | 10.1 | No | Ramp Run Slope RT (%) | 9 |
| Yes | Ramp Cross Slope LT (%) | 1.1 | No | Ramp Cross Slope RT (%) | 2.4 |

**Remove & Replace Curb Ramp With Two New Directional Ramps or Equivalent.**

**R304.3.2, R304.5.3, STD 1115**
