# Access Compliance Report Public Rights-of-Way (Curb Ramps)

| Main Street: EARLHAM_ST | | Cross Street: WASHINGTON_AVE | | Location: | SW |
| ADA ID: RPAT210929150042 | Ramp Type: Type 4 - Parallel | Initial Pass/Fail: Fail | Overall Compliance: No | Severity Score: | 4 |

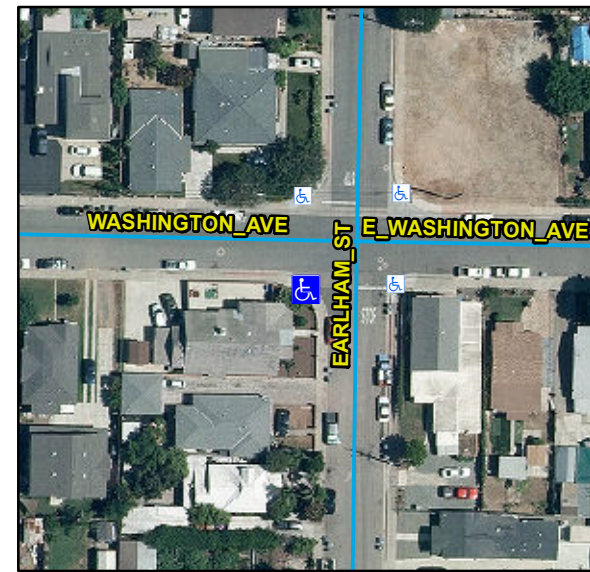
| Compliance | Description | Data | Compliance | Description | Data |
|---|---|---|---|---|---|
| No | Ramp Width LT (in) | 42 | No | Ramp Width RT (in) | 45 |

**Remove & Replace Curb Ramp With Two New Directional Ramps or Equivalent.**

**R304.5.1, STD 1115**

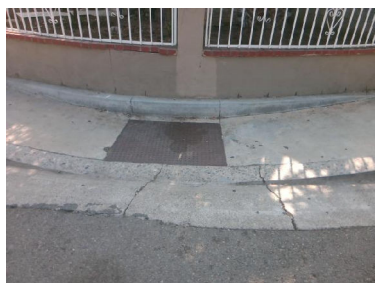
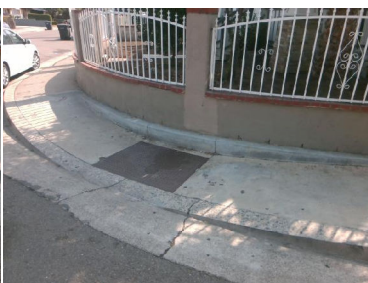
| Compliance | Description | Data | Compliance | Description | Data |
|---|---|---|---|---|---|
| N/A | Ramp Length LT (in) | 114 | N/A | Ramp Length RT (in) | 105 |
| Yes | Ramp Run Slope LT (%) | 5.2 | Yes | Ramp Run Slope RT (%) | 5 |
| Yes | Ramp Cross Slope LT (%) | 0 | Yes | Ramp Cross Slope RT (%) | 0.8 |
