# Access Compliance Report Public Rights-of-Way (Curb Ramps)

Main Street: CHAPMAN\_AVE Cross Street: EARLHAM\_ST Location: SE

ADA ID: RPAT210929150457 Ramp Type: Type 4 - Parallel Initial Pass/Fail: Fail Overall Compliance: No Severity Score: 16

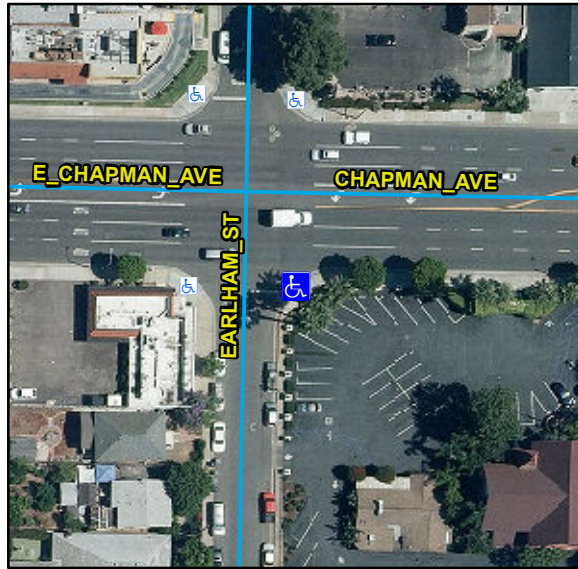
| Compliance | Description | Data | Compliance | Description | Data |
|---|---|---|---|---|---|
| No | Ramp Run Slope LT (%) | 11.5 | Yes | Ramp Run Slope RT (%) | 3.2 |

Remove & Replace Curb Ramp With Two New Directional Ramps or Equivalent.

R304.3.2, STD 1115
