# Access Compliance Report Public Rights-of-Way (Curb Ramps)

Main Street: EARLHAM\_ST Cross Street: CHAPMAN\_AVE Location: NE

ADA ID: RPAT210929150747 Ramp Type: Type 4 - Parallel Initial Pass/Fail: Fail Overall Compliance: No Severity Score: 30

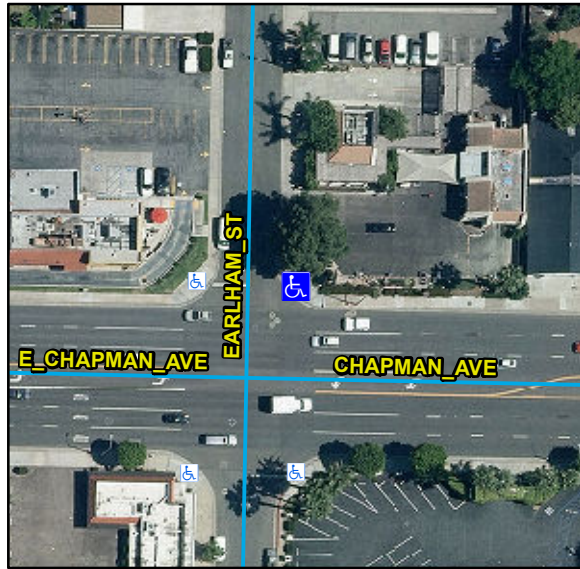
| Compliance | Description | Data | Compliance | Description | Data |
|---|---|---|---|---|---|
| Yes | Ramp Run Slope LT (%) | 5.6 | No | Ramp Run Slope RT (%) | 14.4 |

**Remove & Replace Curb Ramp With Two New Directional Ramps or Equivalent.**

**R304.3.2, STD 1115**
