# Access Compliance Report Public Rights-of-Way (Curb Ramps)

| Main Street: E_CHAPMAN_AVE | | Cross Street: EARLHAM_ST | | Location: | NW |
| ADA ID: RPAT210929151105 | Ramp Type: Type 4 - Parallel | Initial Pass/Fail: Pass | Overall Compliance: No | Severity Score: | 10 |

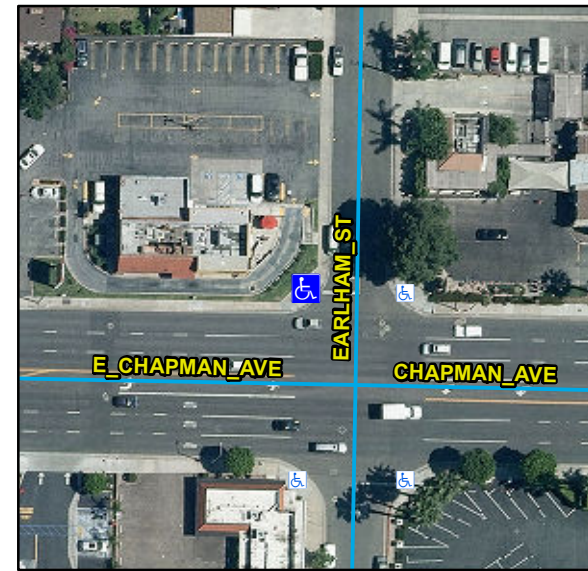
| Compliance | Description | Data | Compliance | Description | Data |
|---|---|---|---|---|---|
| Yes | Landing Run Slope (%) | 1.5 | No | DWS Full Width | No |
| No | Gutter Run Slope (%) | 5.6 | | Road Cross Slope (%) | 4.5 |

Possible Solutions:

Remove & Replace Detectable Warning System.  
Remove & Replace Gutter.

R305.1.4, R304.5.4, STD 1115

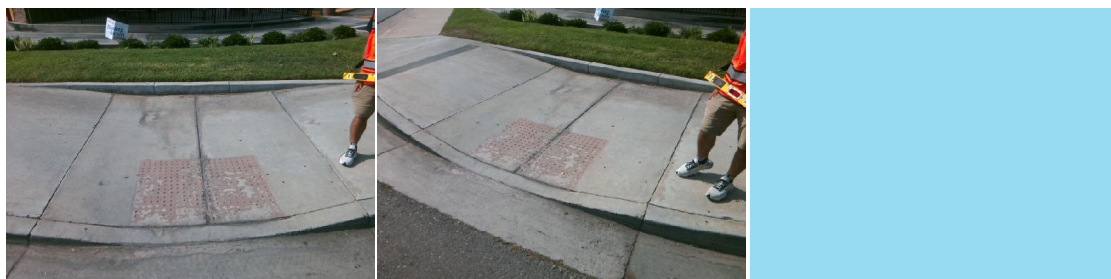
| Compliance | Description | Data | Compliance | Description | Data |
| N/A | Ramp Length LT (in) | 68 | N/A | Ramp Length RT (in) | 70 |
| Yes | Ramp Width LT (in) | 113 | Yes | Ramp Width RT (in) | 104 |
| Yes | Ramp Run Slope LT (%) | 8.2 | Yes | Ramp Run Slope RT (%) | 7.1 |
