# Access Compliance Report Public Rights-of-Way (Curb Ramps)

Main Street: CALVO\_DR Cross Street: ETHELBEE\_WAY Location: NW

ADA ID: RPAT210930084411 Ramp Type: Type 1 - Perpendicular Diagonal Initial Pass/Fail: Pass Overall Compliance: No Severity Score: 22

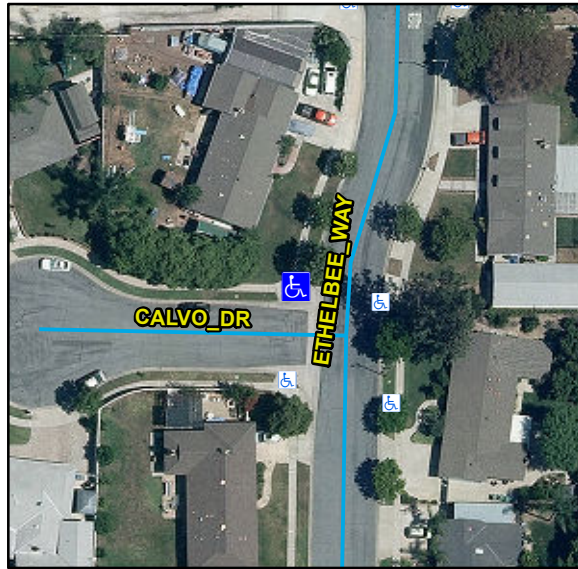
| Compliance | Description | Data | Compliance | Description | Data |
|---|---|---|---|---|---|
| No | Landing Width (in) | N/A | N/A | Flare Slope RT (%) | 5.4 |
| No | Landing Run Slope (%) | N/A | N/A | Flare Traversable RT | No |
| No | Landing Cross Slope (%) | N/A | No | DWS Provided | No |

**Remove & Replace Curb Ramp With Two New Directional Ramps or Equivalent.**

**R204.3, R304.2.1, R304.2.2-Perp, R304.3.2-Para, R304.5.3, R305, STD 1115**

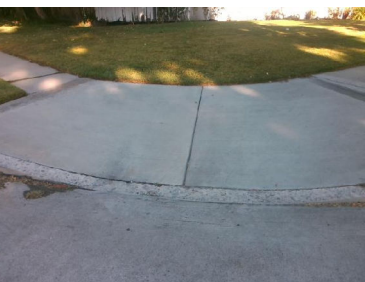
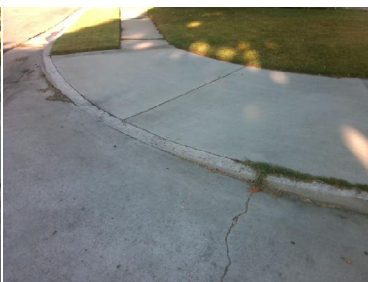
| Compliance | Description | Data | Compliance | Description | Data |
|---|---|---|---|---|---|
| Yes | Overall Surface Condition: <b>Acceptable</b> | | No | Perp Joint Present | No |
