# Access Compliance Report Public Rights-of-Way (Curb Ramps)

Main Street: KEEGAN\_WAY Cross Street: ETHELBEE\_WAY Location: NW

ADA ID: RPAT210930085101 Ramp Type: Type 1 - Perpendicular Diagonal Initial Pass/Fail: Fail Overall Compliance: No Severity Score: 2

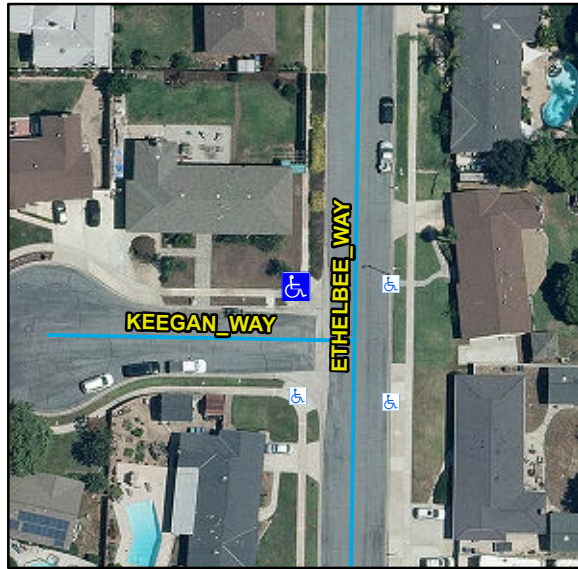
| Compliance | Description | Data | Compliance | Description | Data |
|---|---|---|---|---|---|
| No | Ramp Cross Slope (%) | 2.9 | N/A | Flare Traversable LT | N/A |

Remove & Replace Curb Ramp With Two New Directional Ramps or Equivalent.

R304.2.2, R304.5.3, STD 1115
